# PELICAN RIVER DAM ROCK MASONRY WALL FAILURE ASSESSMENT REPORT

Pelican Rapids, Minnesota

March 9, 2017

Houston Engineering, Inc.

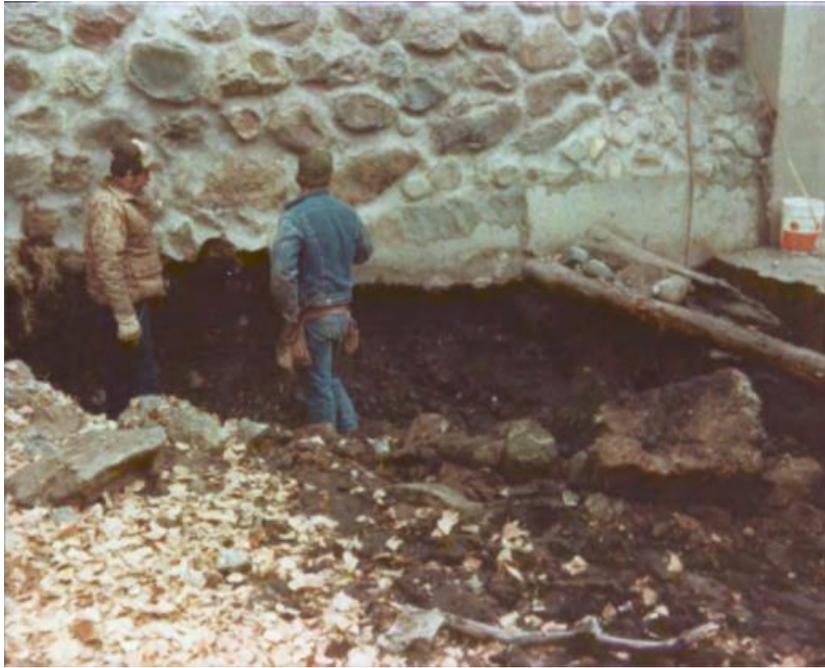
This photograph shows the lack of foundation under the rock wall on the downstream end of the dam. This was excavated, one short distance at a time, and a footing was put in place.

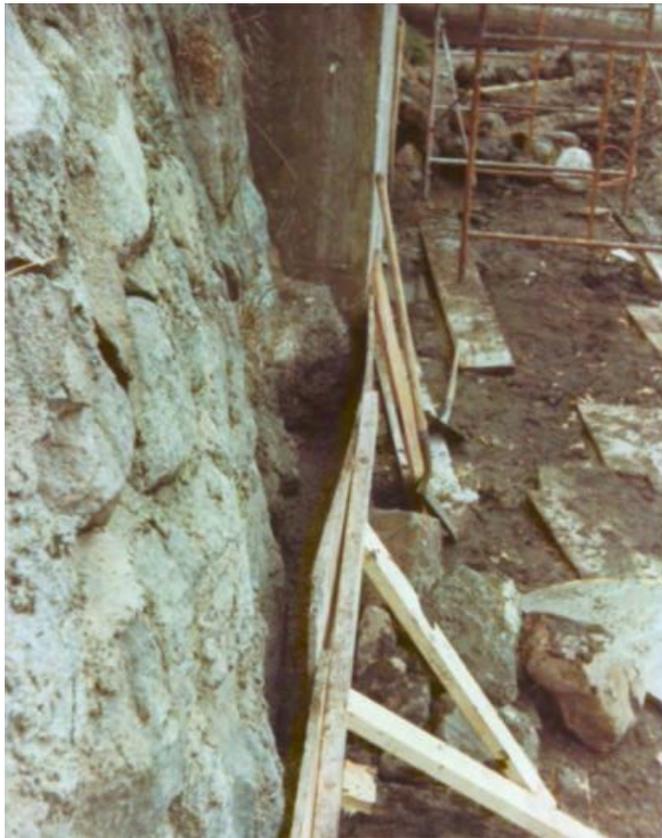
The footing area being formed up under the rock wall.

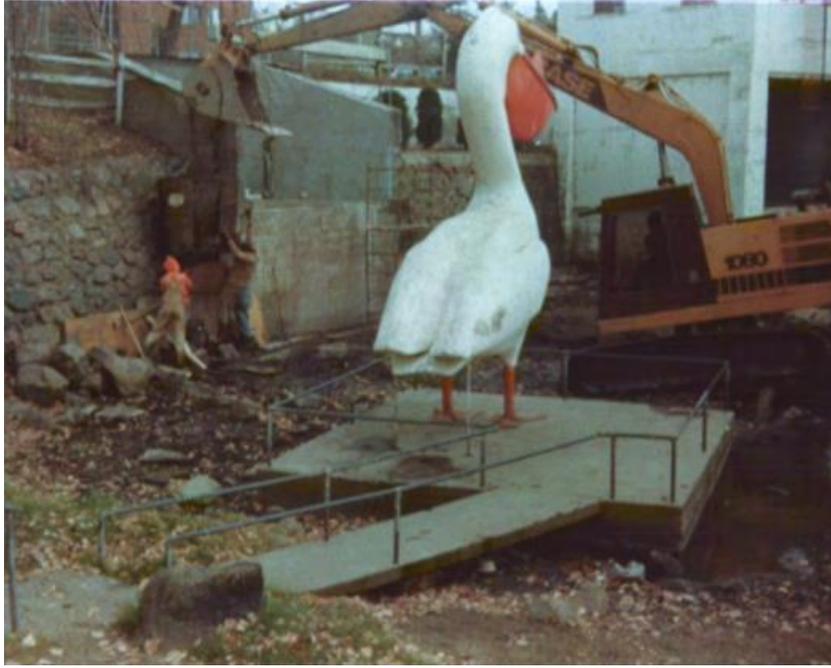
The footing area is being filled. This footing was put in place under the rock wall for obvious reasons and was done in sections

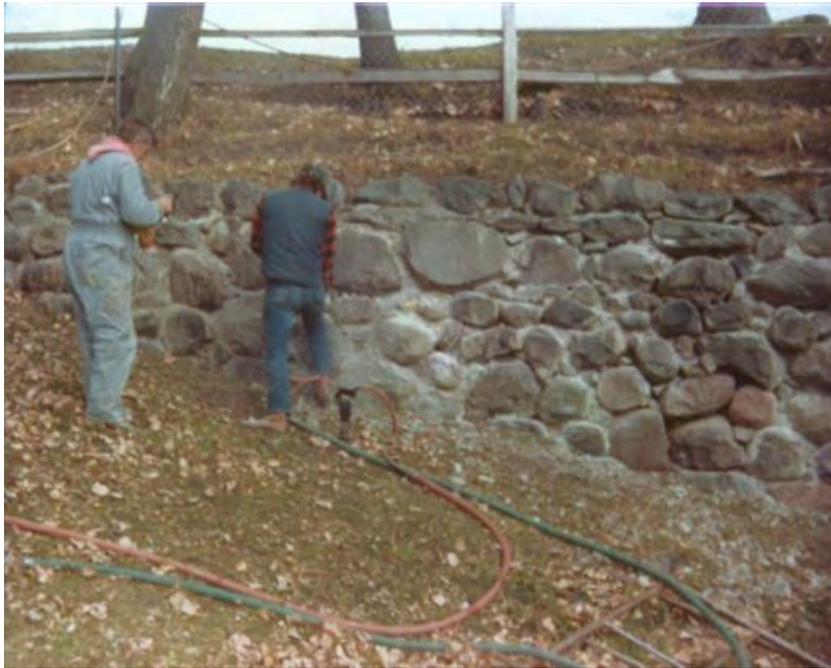
The grout on the old rocks had severely degraded and lost its ability to bond. The old grout was air hammered out, the rock was sandblasted, and new grout was added.

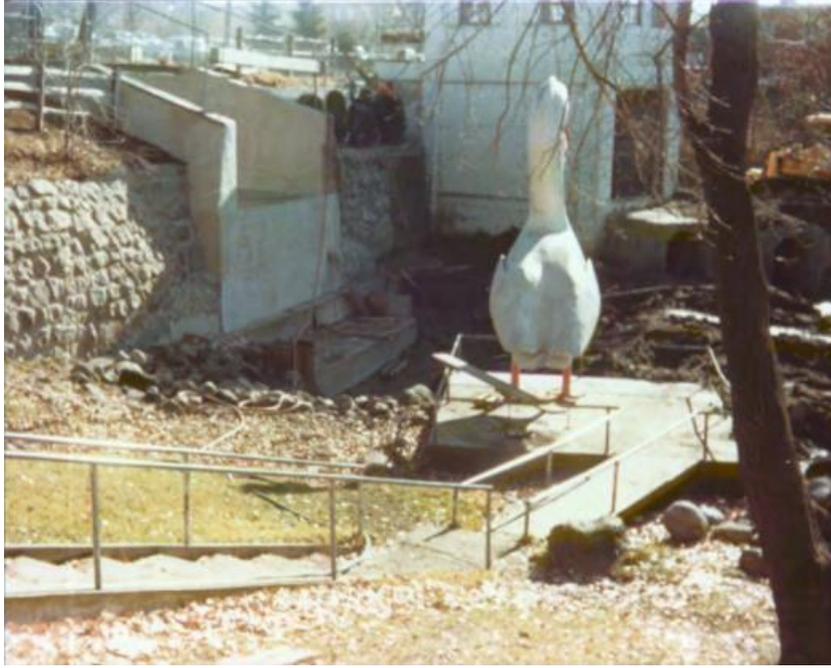
This photograph shows the downstream end of the dam prior to letting water come back into the dam but after the rock walls were re-grouted and after the new foundation for the downstream end of the spillway was put in place.

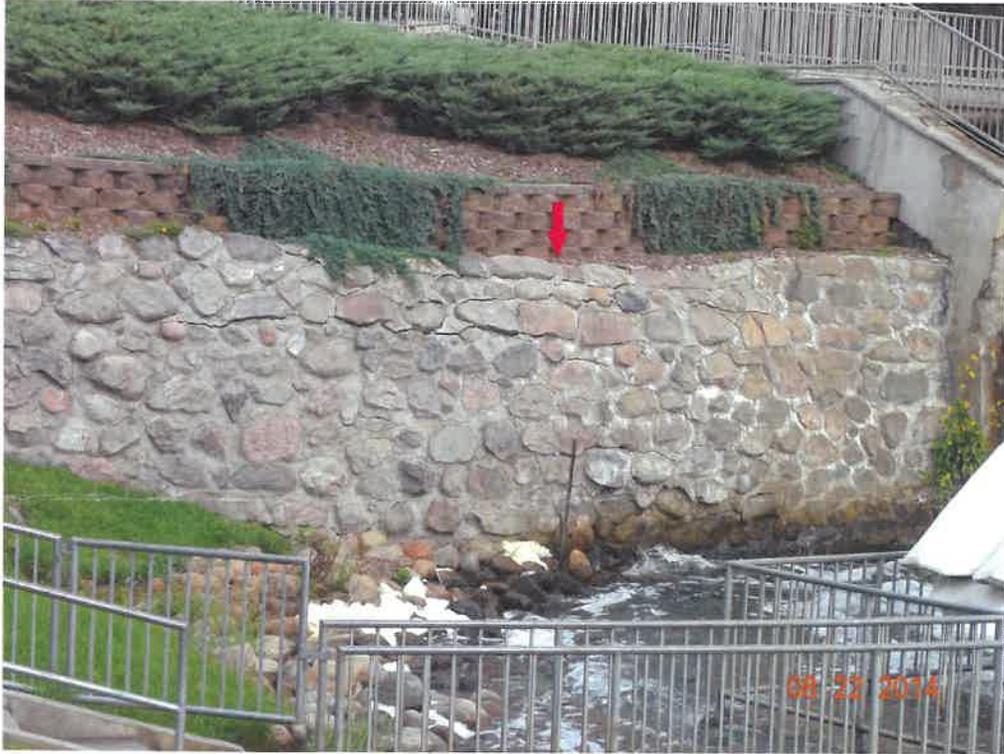
Photo 1 (8/22/2014) - Showing right downstream masonry rock wall. Location of void is below the red arrow. Seepage outlets at the base of the wall near the fence post and to the right.

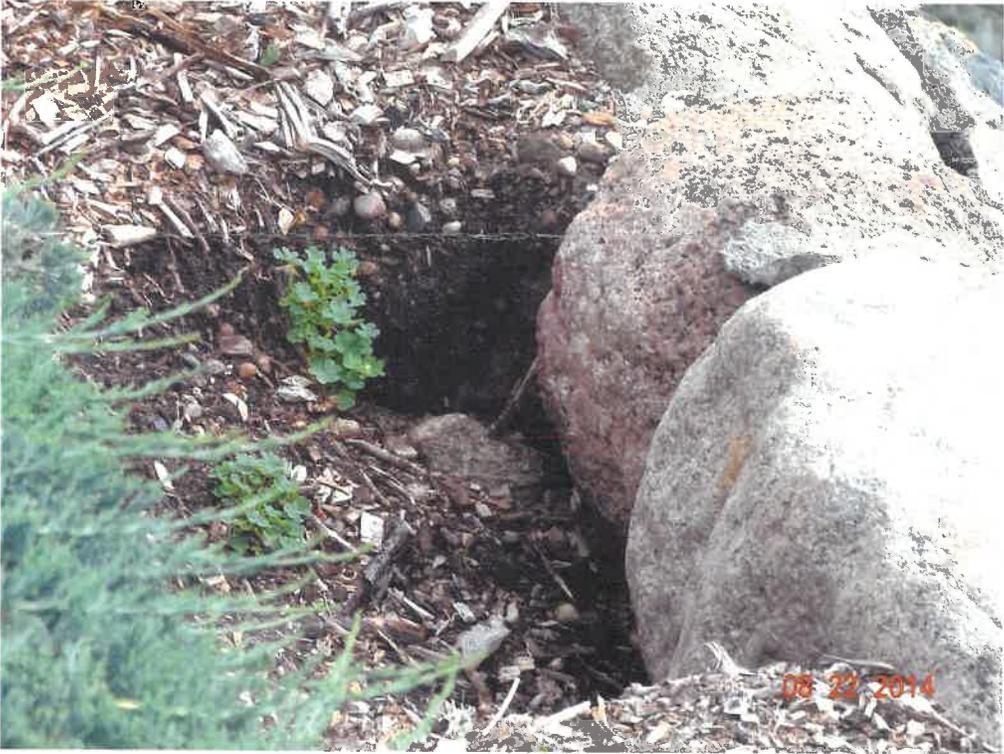
Photo 2 (08/22/2014) - Close up of void forming behind masonry rock wall.

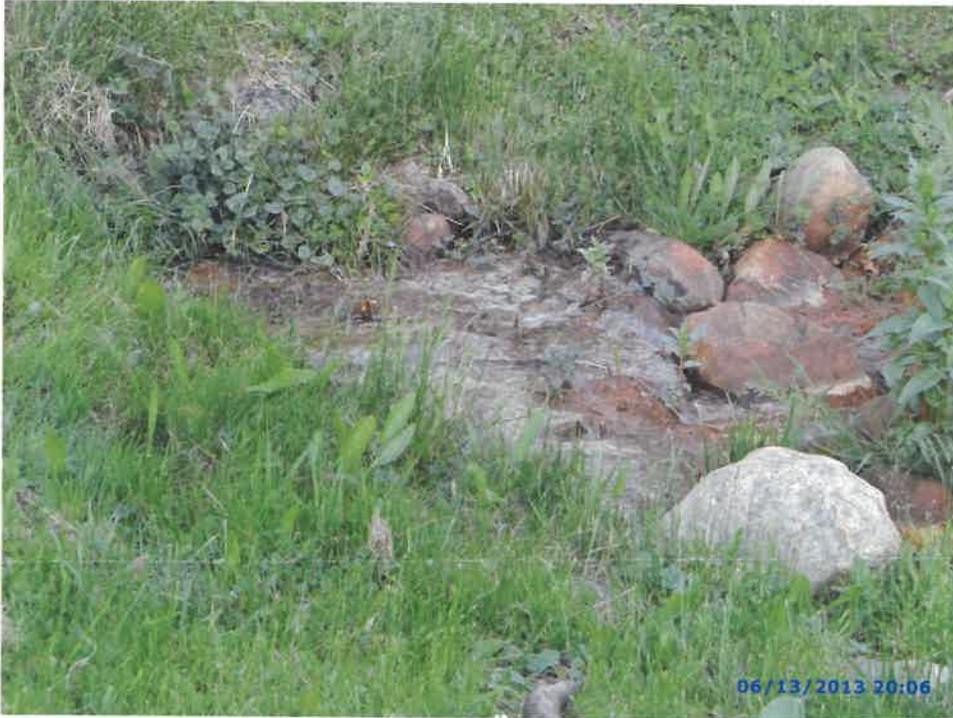
Photo 1 - (6/13/2013) Seepage in the embankment below the right downstream rock wall.

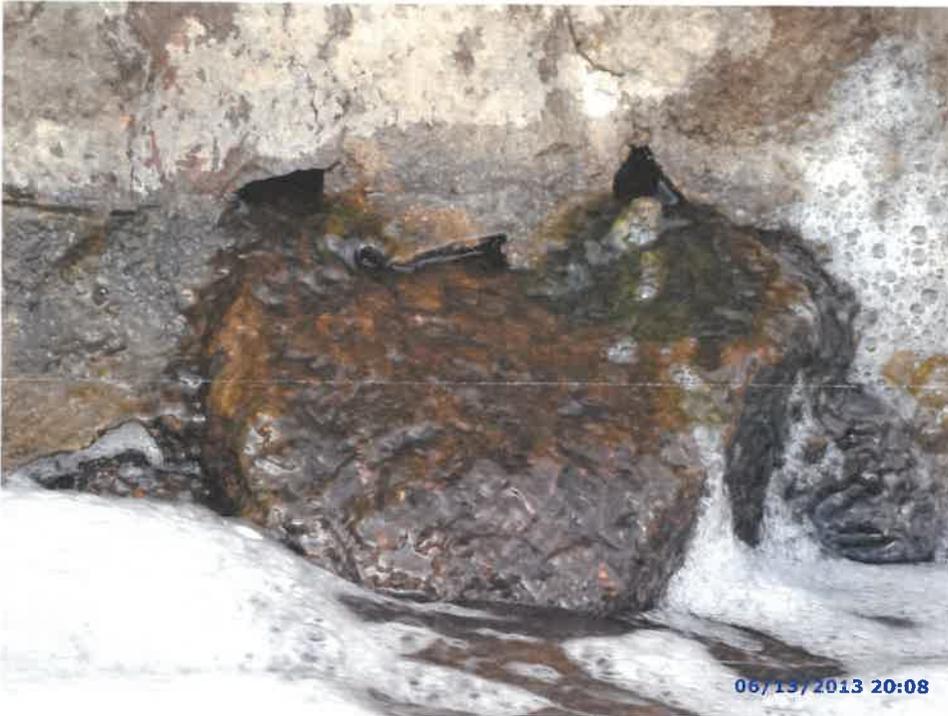
Photo 2 - (6/13/2013) Seepage flowing out of the right downstream rock retaining wall.

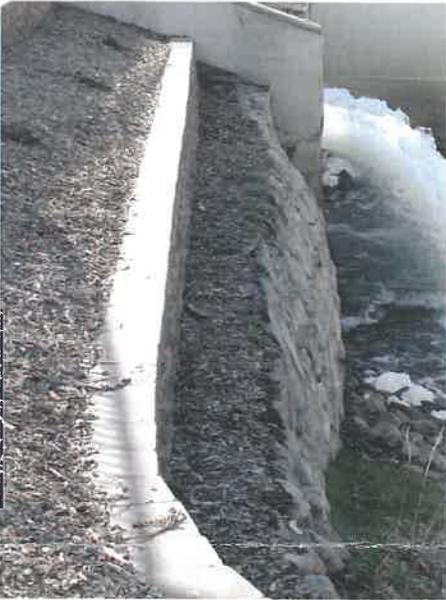
Photo 1 (4/18/2007) - showing the middle brick retaining wall and the lower rock masonry wall. Note the straight condition of the wall. This photo was taken approximately 8 months after completion.

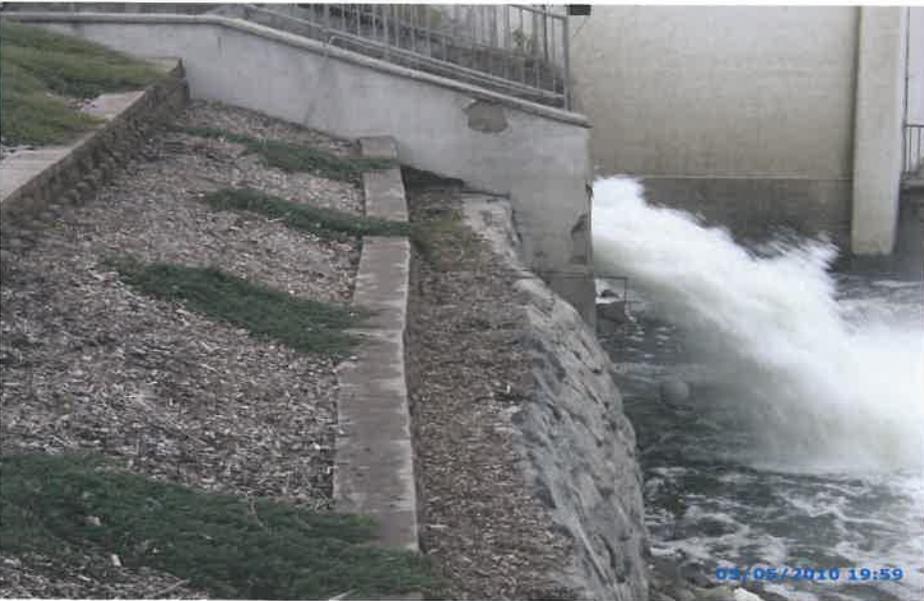
Photo 2 (9/5/2010) - showing the middle brick retaining wall and the lower rock masonry wall. Note the change from the original condition shown in photo 1.

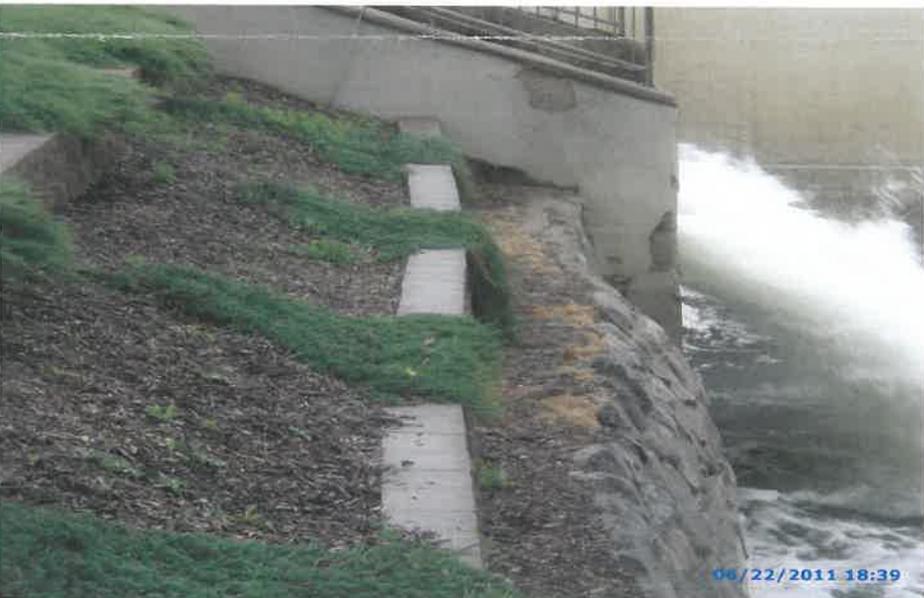
Photo 3 (6/22/2011) - showing the middle rock retaining wall and the lower rock masonry wall.

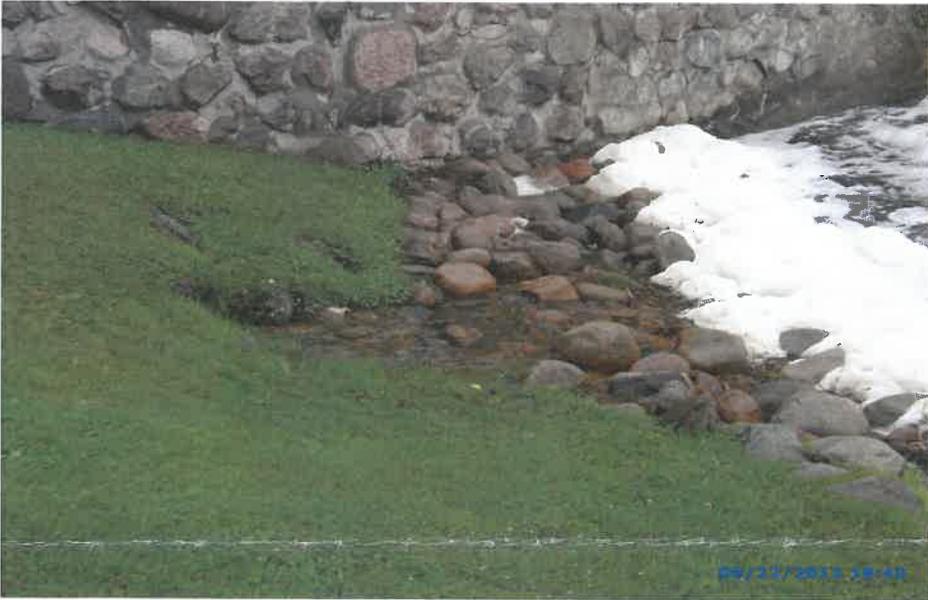
Photo 4 (6/22/2011) - seepage flowing on downstream right side of dam. Additional seeps below the dam were obscured by high tailwater.

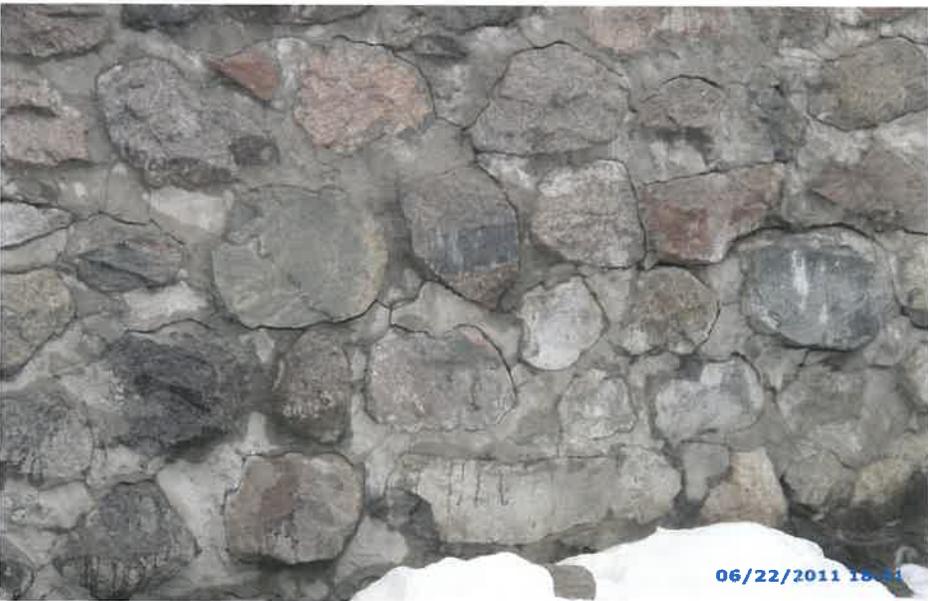
Photo 5 (6/22/2011) - Cracking around boulders. Note water flowing out of cracks and onto the boulders.

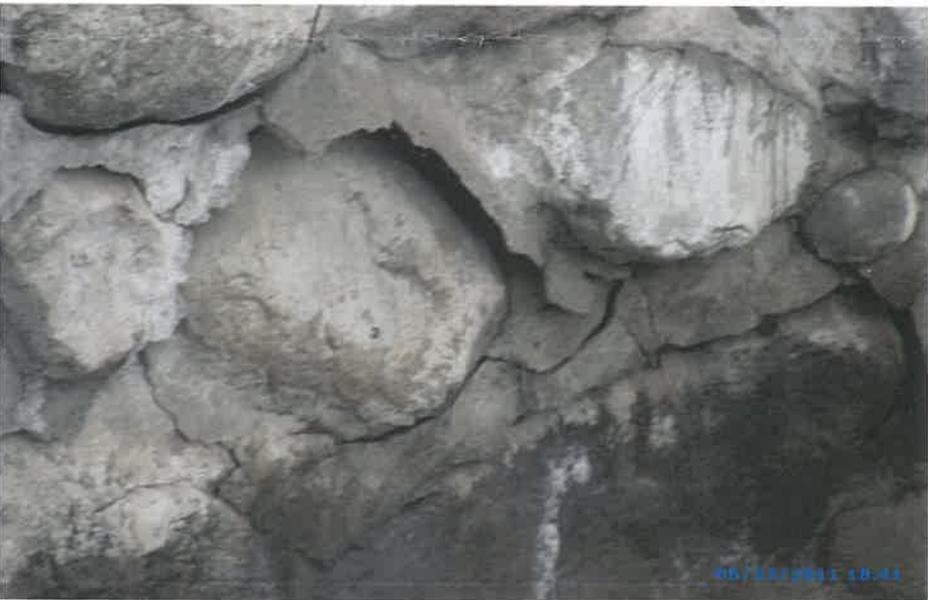
Photo 6 (6/22/2011) - Cracks and displacement in the masonry rock wall.

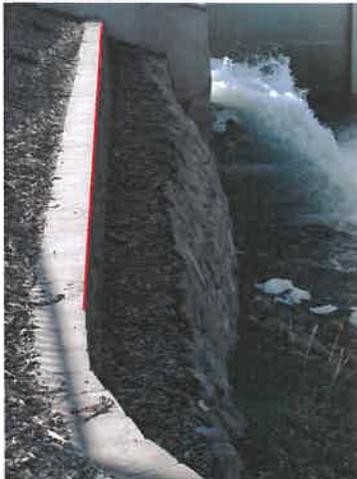
4/18/2007 – Photo of recently constructed block retaining wall over the masonry rock wall. Note that the wall is essentially straight.

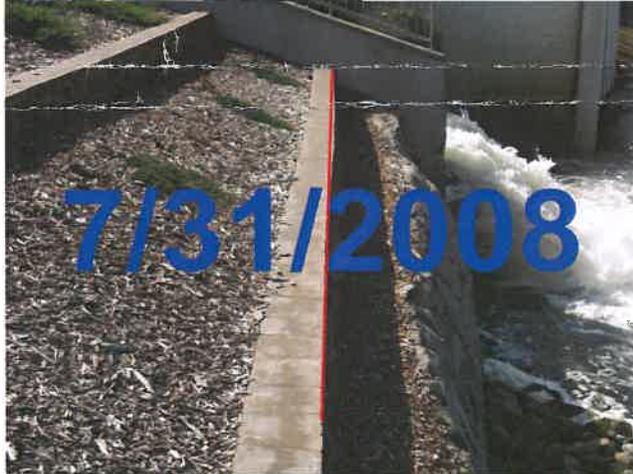
7/31/2008 – Slight bulge noted in the brick masonry wall indicating some downstream movement.

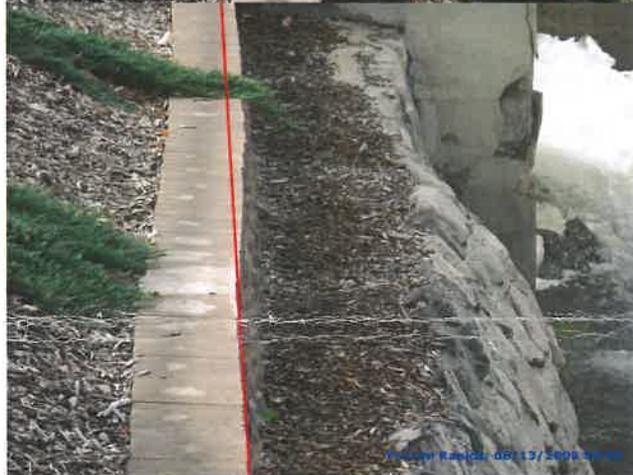
8/13/09 – Continued movement of the brick retaining wall in the downstream direction. It is assumed that the lower masonry wall is also moving.

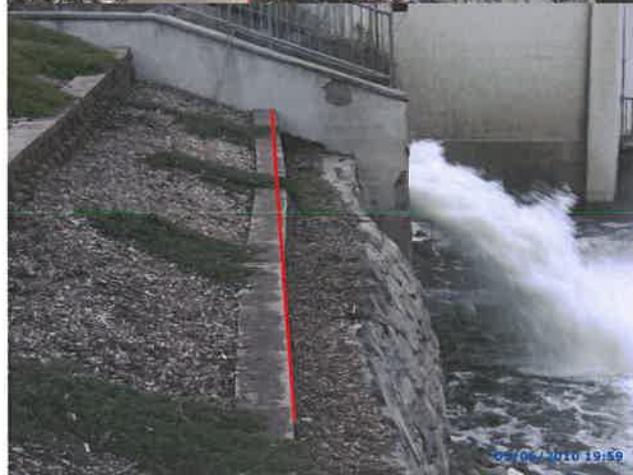
05/05/2010 – Conditions as of May 5, 2010. The device constructed for measuring the downstream movement of the masonry rock wall may not be recording the total movement as that device may also be moving. Running a tape between two points on the brock wall and measuring the offset of specific bricks may be a more accurate method of recording displacement and rate of movement.

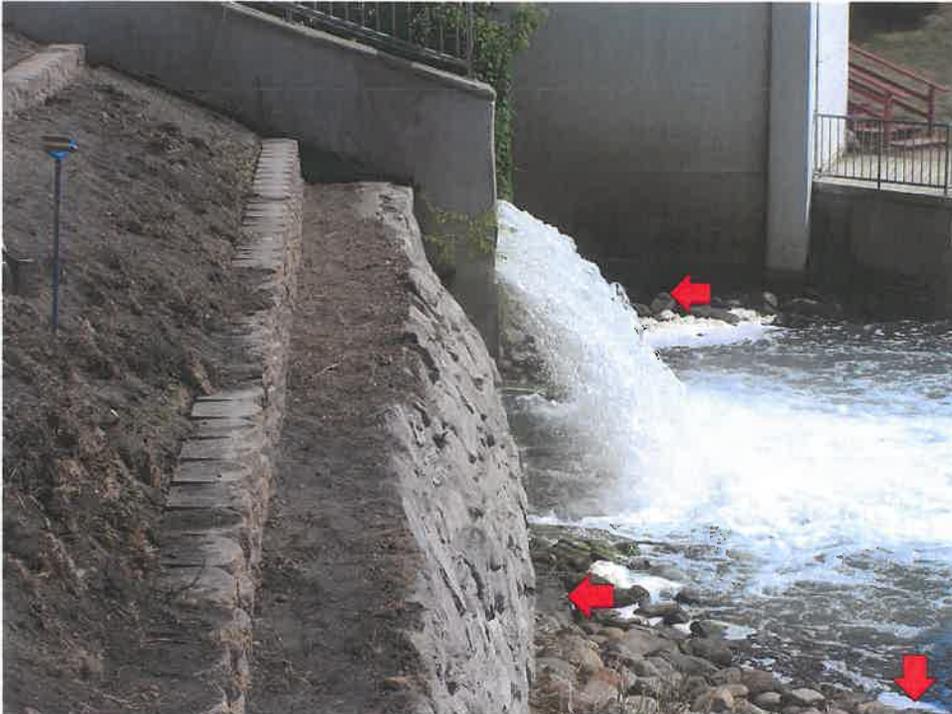
Photo 1 (08/08/2006) - Face of north side of Pelican Lake Dam. Note bulge near the center of the rock structure. Historic photos show a large tree above the bulge site. Photos from 1995 to 2005 show a large stump.

Seepage was observed in three locations, at the base of the downstream left embankment, below the bulge, and in the soil approximately 10 feet downstream of the dam (see red arrows). Seepage is shown in photos 2, 3 and 4.

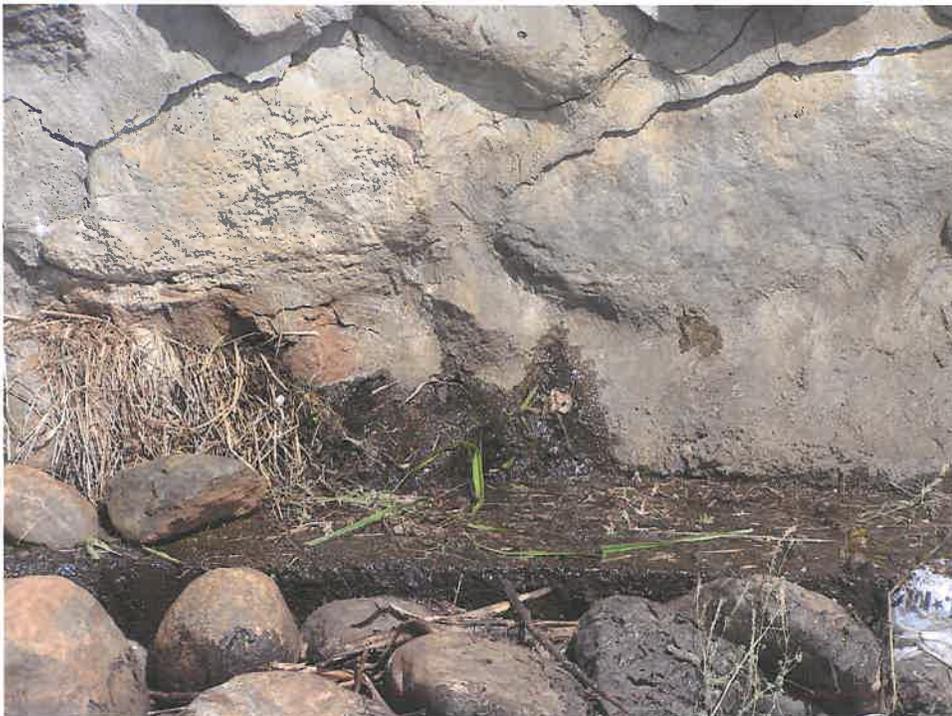
Photo 2 (08/08/2006) - Seepage below bulge in downstream retaining wall. This seepage is often obscured by high tailwater conditions. In the rock face, note the cracking of the concrete.

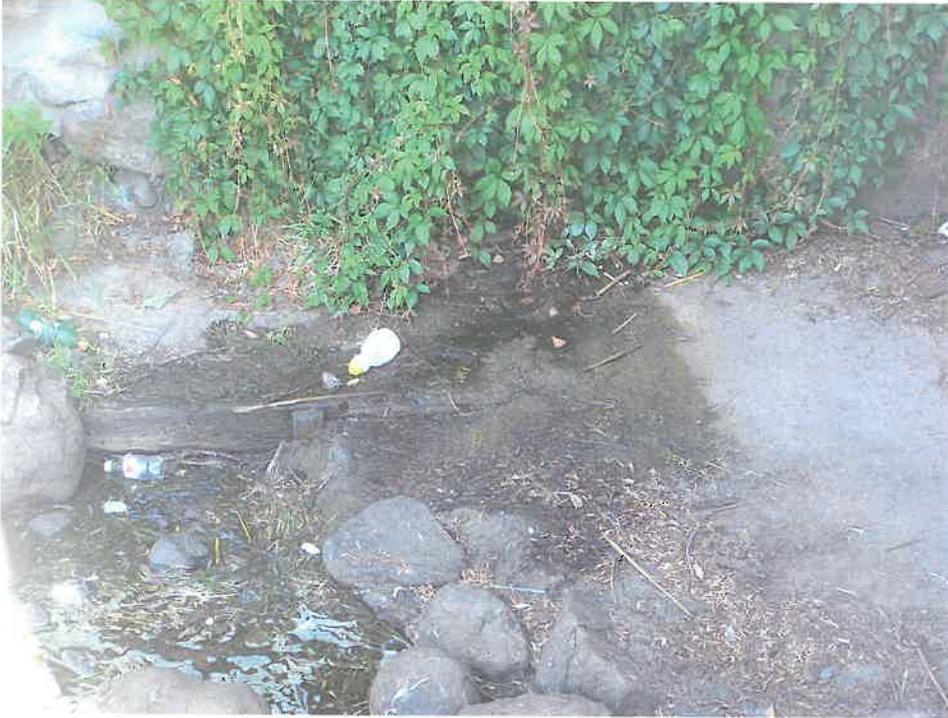
Photo 3 (08/08/2006) - Seepage on left downstream face of the rock retaining wall near the powerhouse. Vegetation made it difficult to inspect condition of retaining wall.

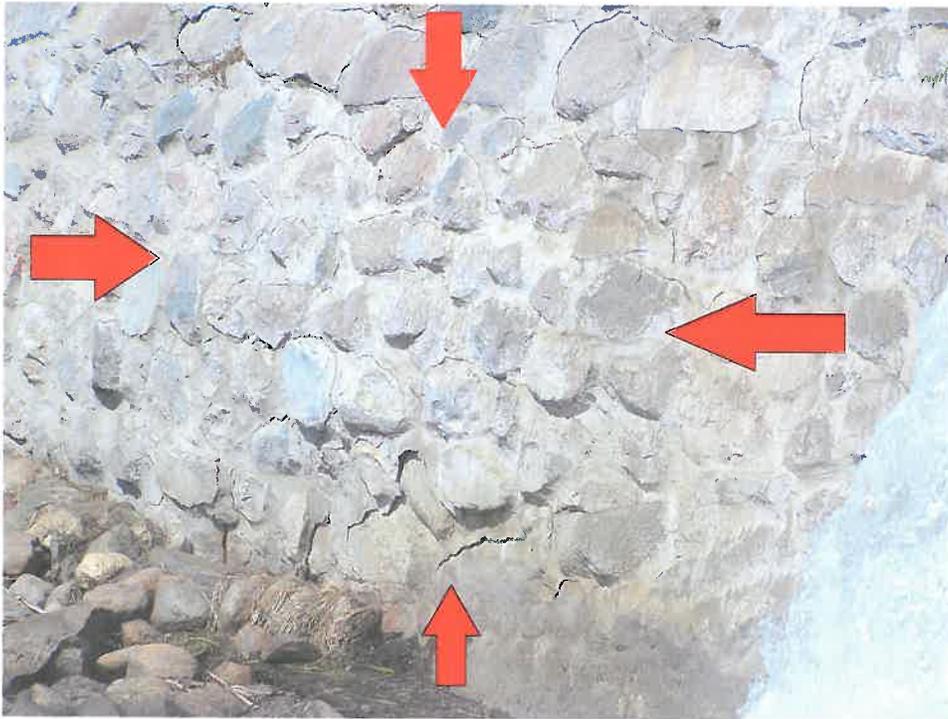
Photo 4 (08/08/2006) - Bulge in rock face on right downstream face. Note seepage at base of bulge. Note separation and displacement of concrete from boulders. The bulge is approximately the area inside the red arrows.

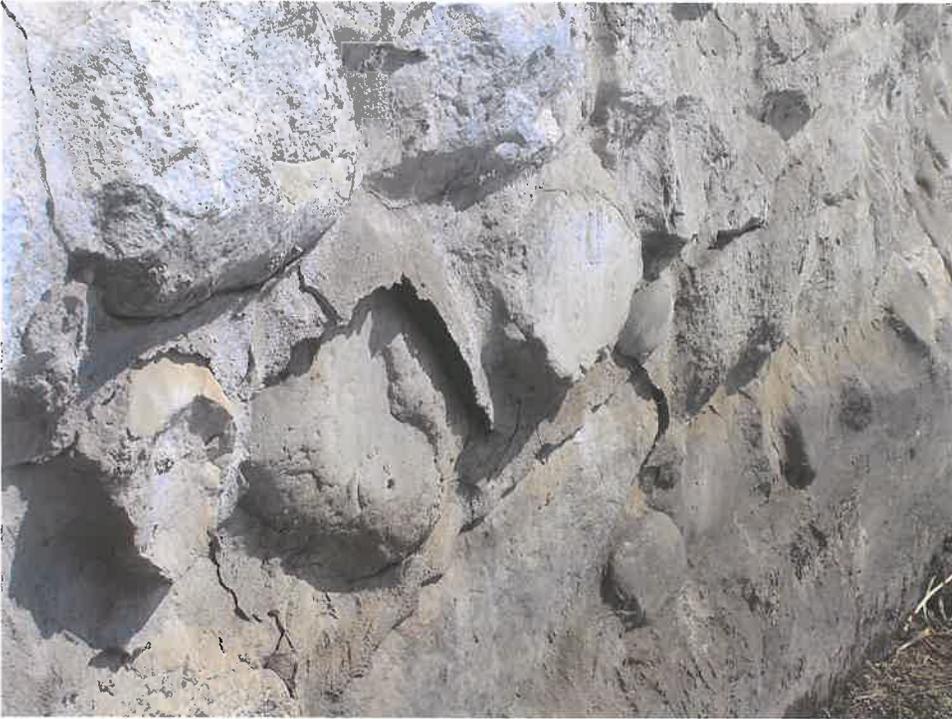
Photo 5 (08/08/2006) - Close up of rock wall separation and displacement.

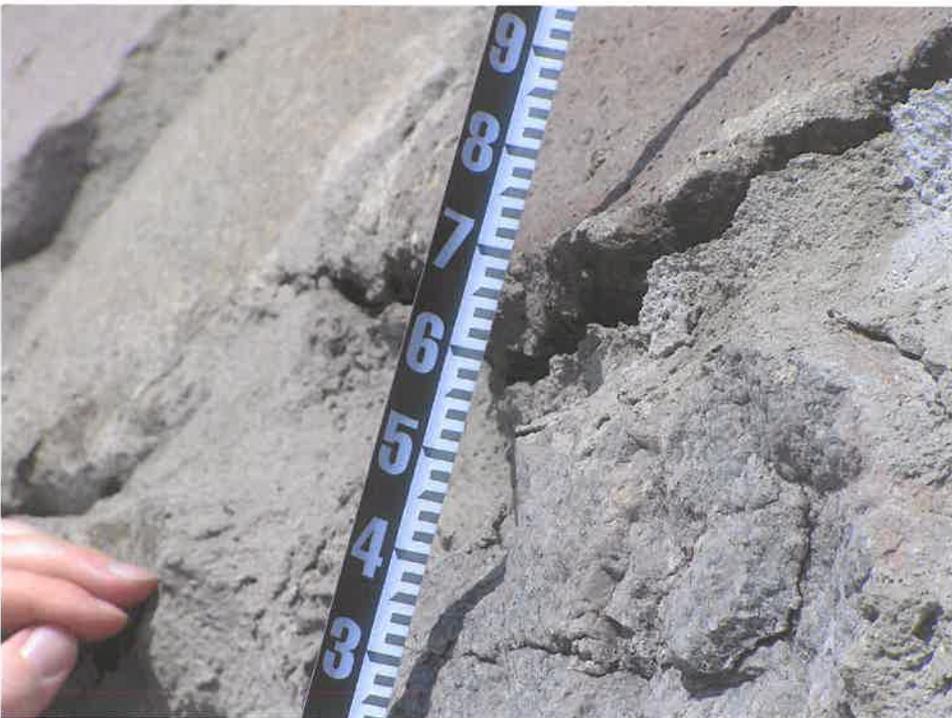
Photo 6 (08/08/2006) - Photo of crack and displacement in rock wall. This picture is in the bulge on the right downstream side of the retaining wall.

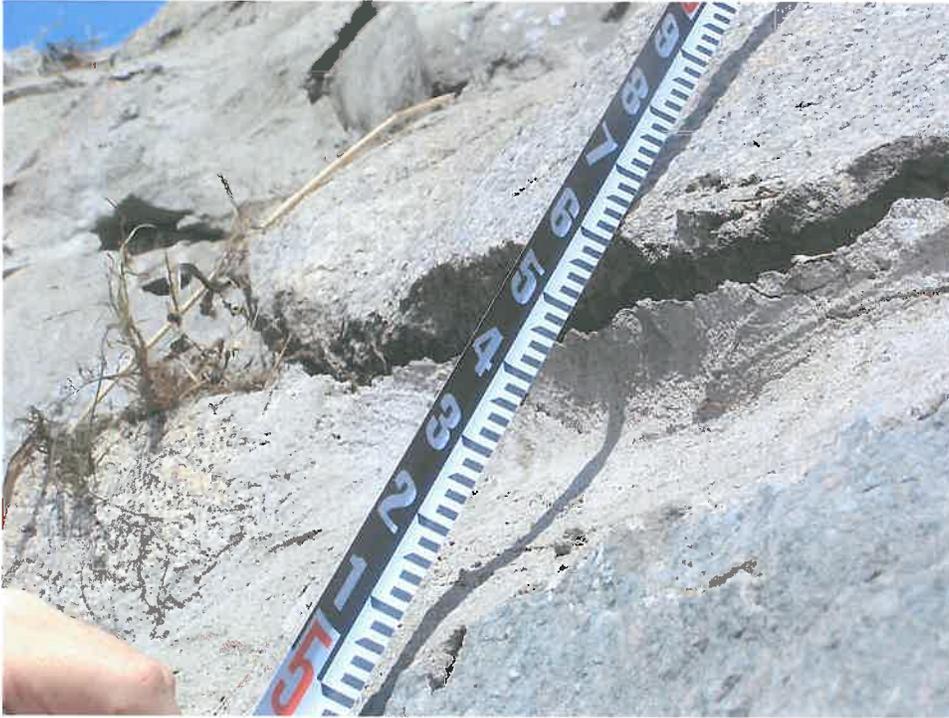
Photo 7 (08/08/2006) - In the bulge, 1-inch crack, displacement and separation of boulder from concrete. Note vegetation growing in crack.

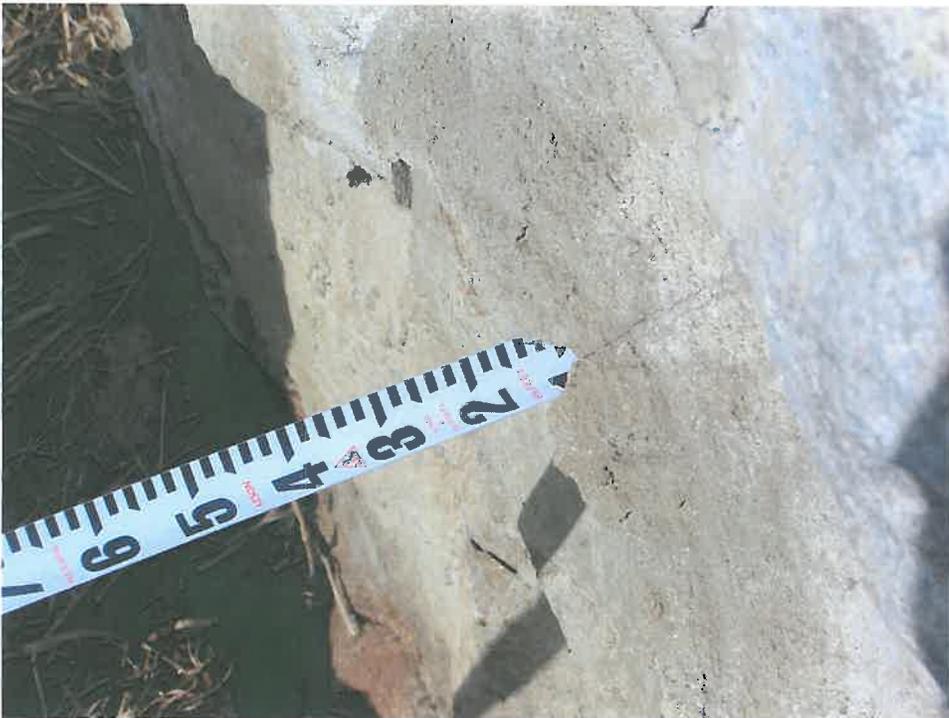
Photo 8 (08/08/2006) - In the bulge. 1.5-inch displacement of boulder and concrete from base of rock wall.

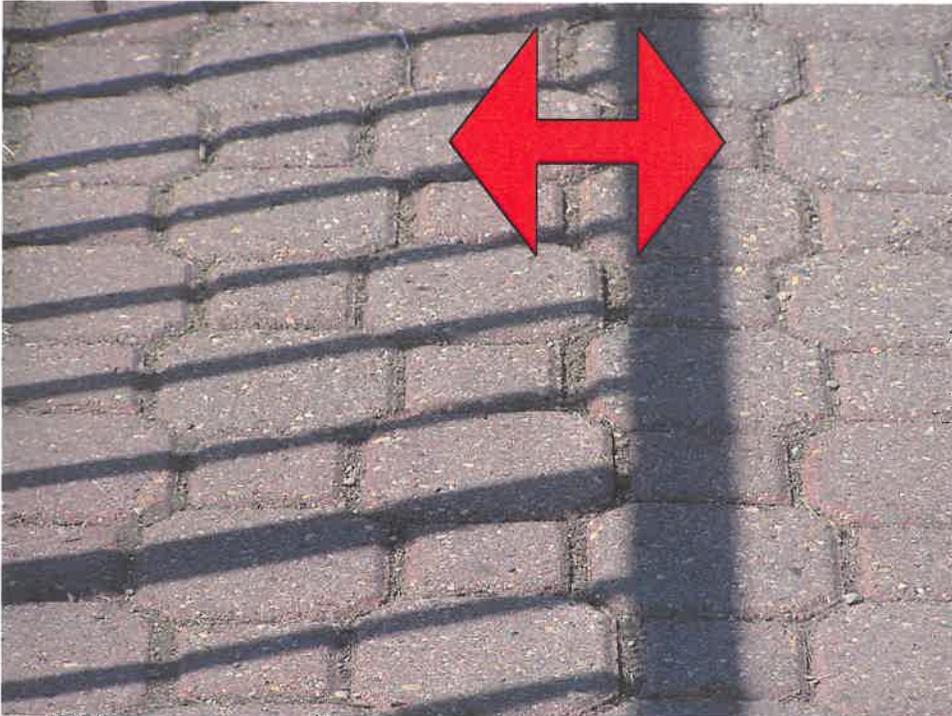
Photo 9 (08/08/2006) - Above the bulge on the brick walkway. The bricks on the right (upstream) side are tightly packed and generally flat. The bricks on the left (downstream) side have a slight dip in the downstream direction. Note the joint in the bricks between the arrows and the change in joint size and material in the joint. Compare to the flush bricks on the right with some soil on the beveled edge. The bricks on the right are stable while the bricks on the left indicate a creep in the downstream direction

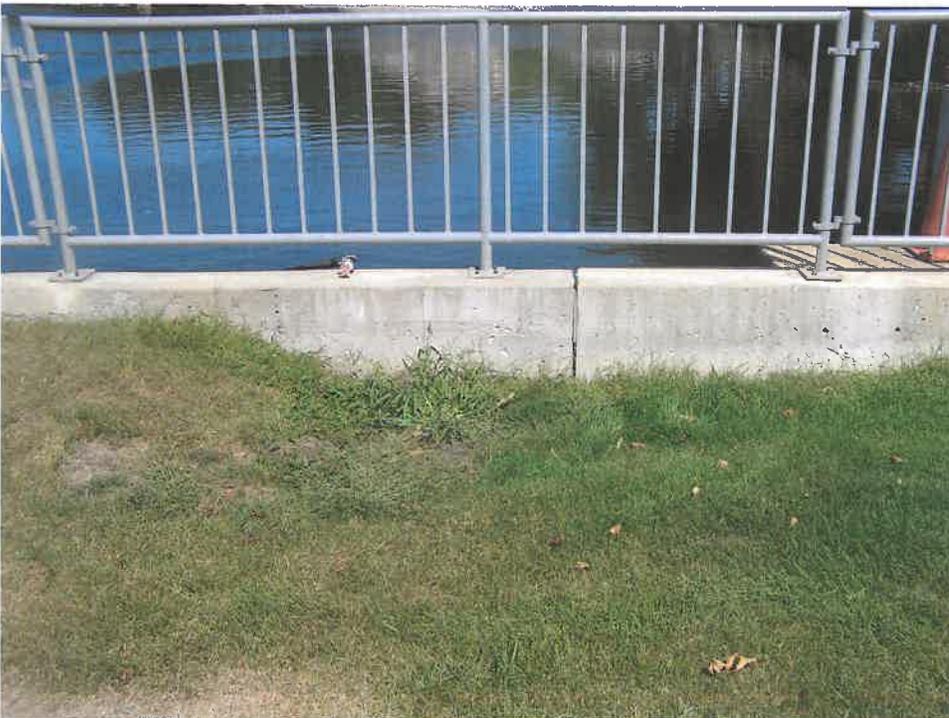
Photo 10 (08/08/2006) - Subsidence / loss of material on the left upstream side of embankment. Downstream of this site, the left wall is separating from the embankment (photo 11) and seepage is occurring at the base of the wall.

The subsidence in this area has existed for at least 10 years. It has been filled and leveled at least on one other occasion. This area should be filled again, leveled and watched for continued subsidence.

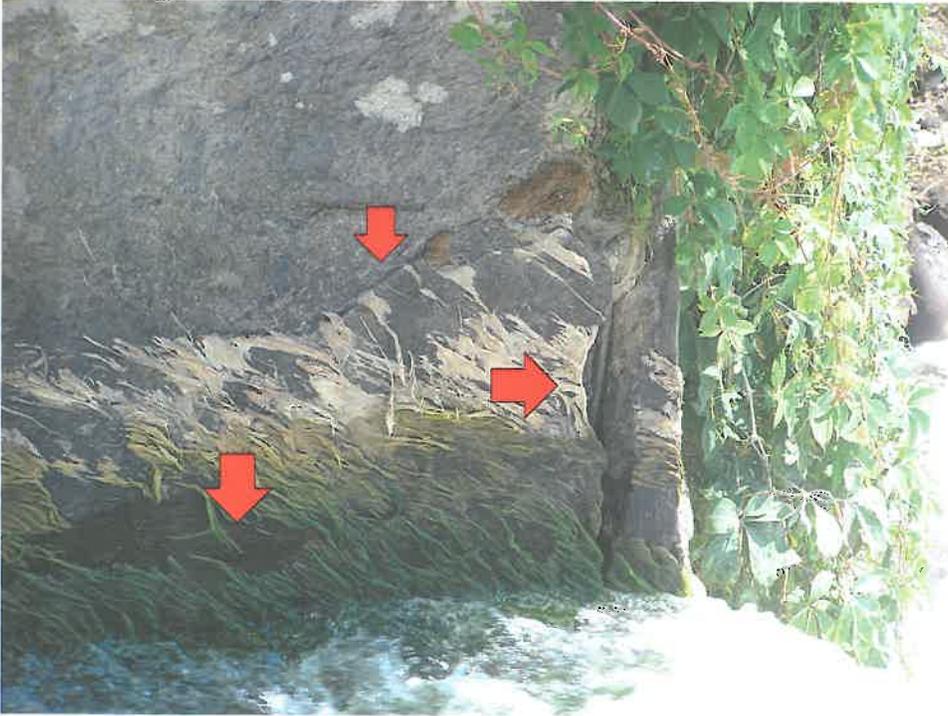
Photo 11 (08/08/2006) - Left Spillway wall (trending east-west) is shown on the left side of the photo. Left embankment wall (trending north-south) is to the immediate left of the vegetation. Note the separation of the left embankment wall from the left spillway wall.

The red arrows show fractures in the spillway wall.

The seepage shown in photo 3 is at the base of this embankment wall.

Vegetation prevented viewing of most of the left embankment wall.

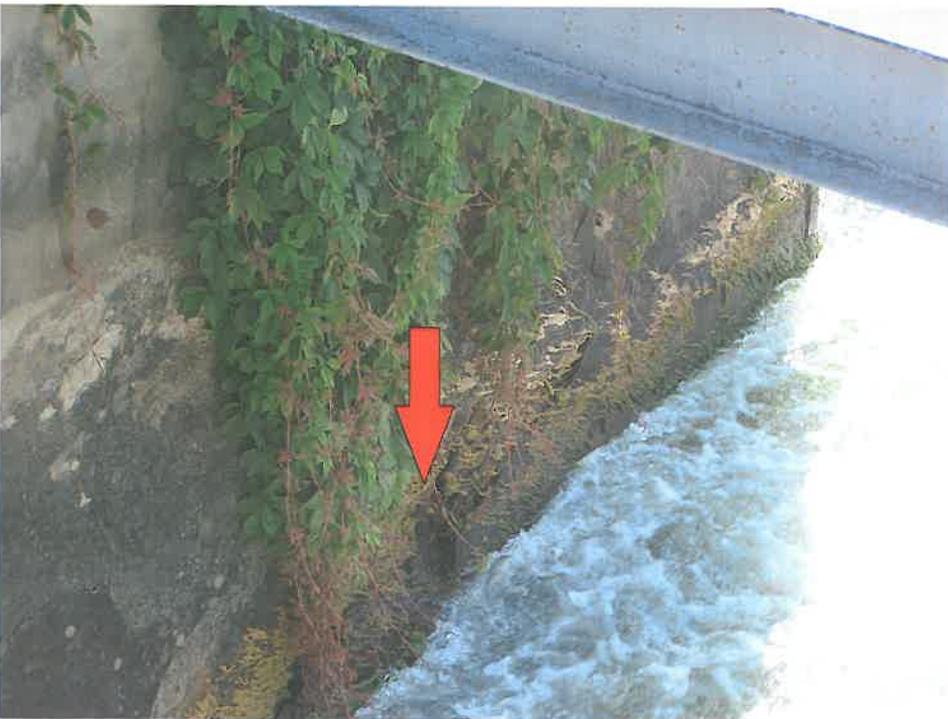
Photo 12 (08/08/2006) - Looking at left spillway wall showing additional fractures in the left spillway wall.

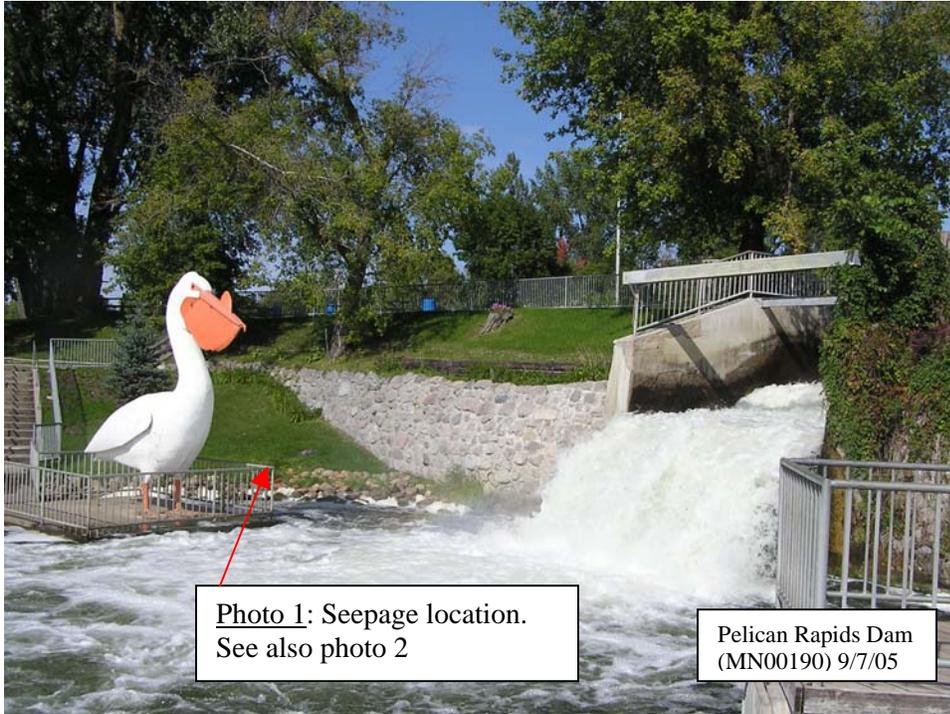
Pelican Rapids Dam  
(MN00190) 9/7/05

Photo 1: Seepage location.  
See also photo 2

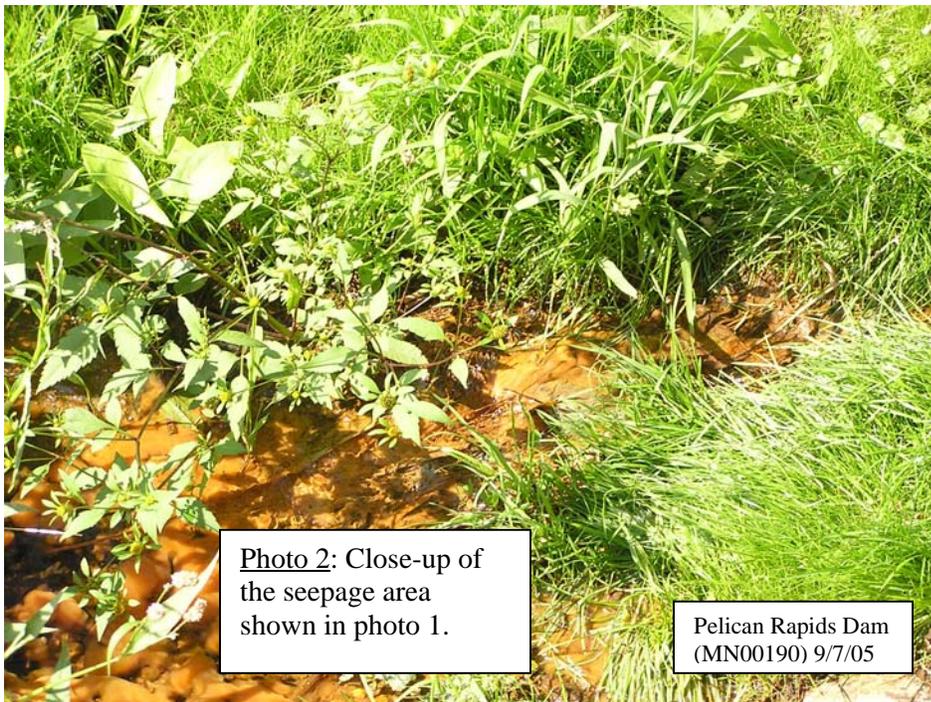
Pelican Rapids Dam  
(MN00190) 9/7/05

Photo 2: Close-up of  
the seepage area  
shown in photo 1.

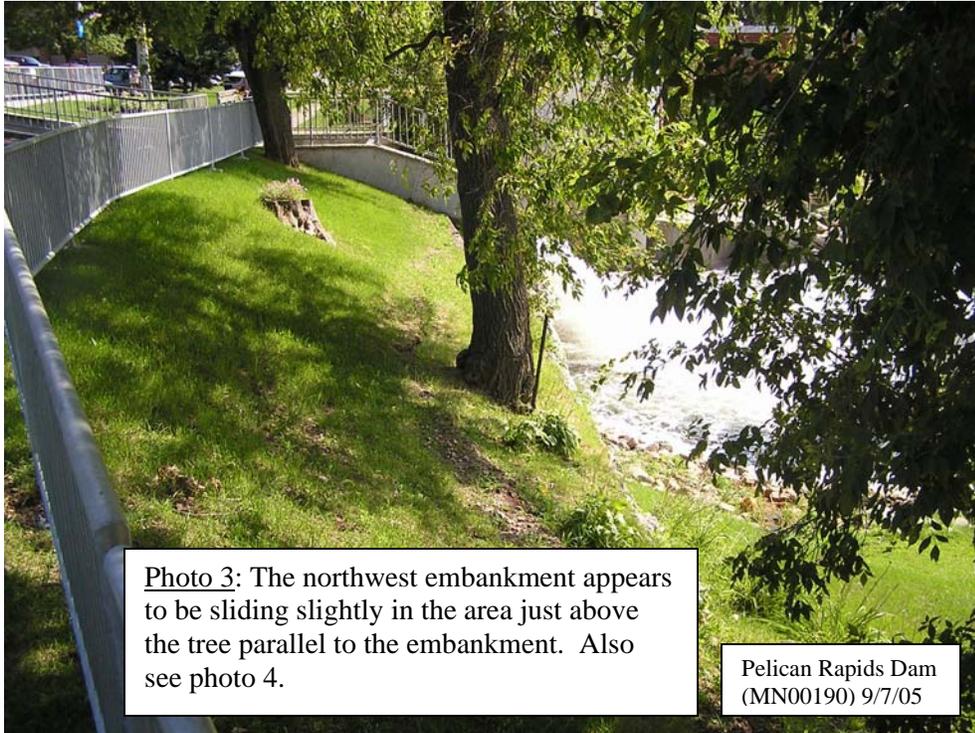
Pelican Rapids Dam  
(MN00190) 9/7/05

Photo 3: The northwest embankment appears to be sliding slightly in the area just above the tree parallel to the embankment. Also see photo 4.

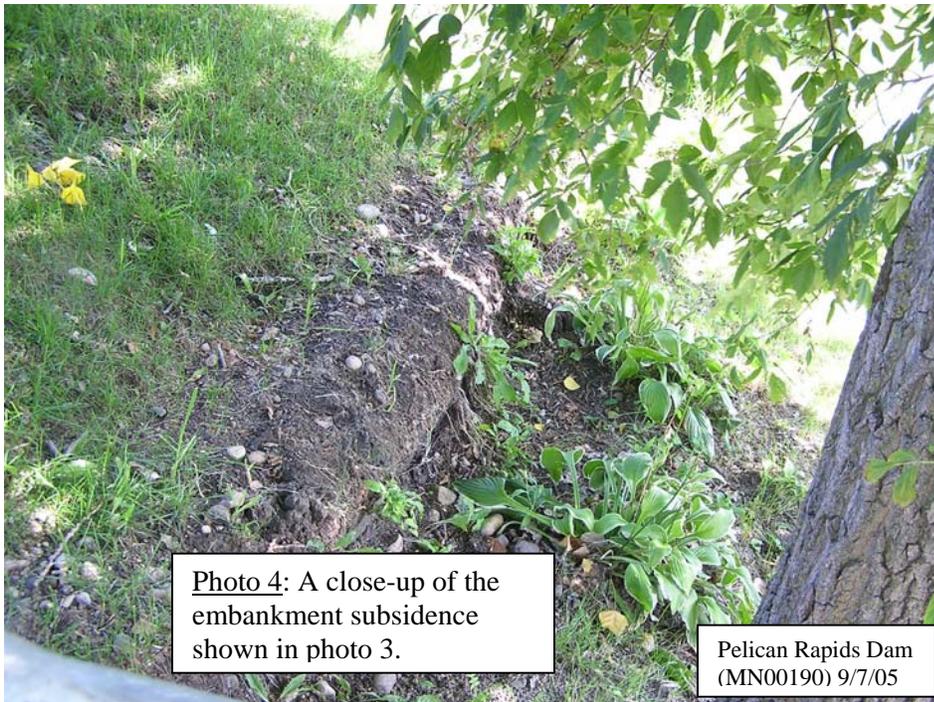
Pelican Rapids Dam  
(MN00190) 9/7/05

Photo 4: A close-up of the embankment subsidence shown in photo 3.

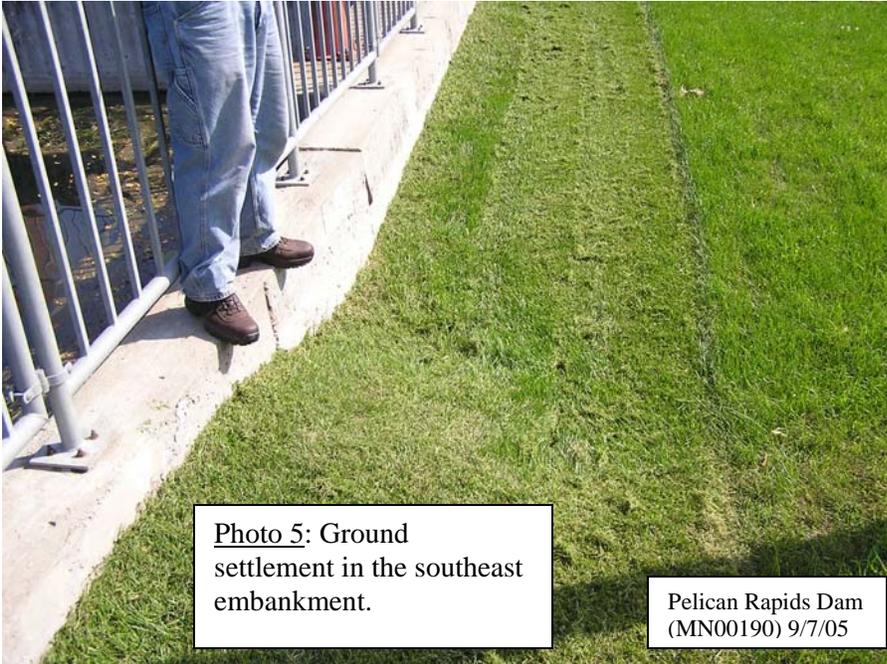
Pelican Rapids Dam  
(MN00190) 9/7/05

Photo 5: Ground settlement in the southeast embankment.
