INTRODUCTION

BATHHOUSE ASSESSMENT

POOL ASSESSMENT

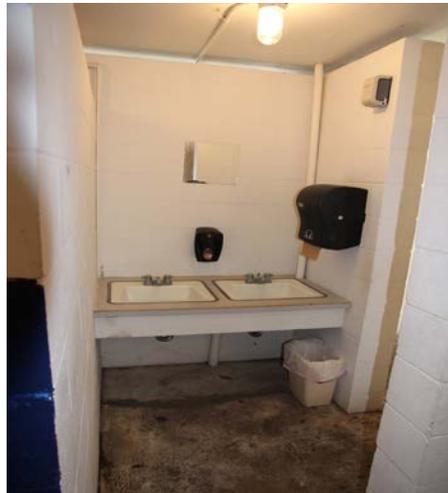
Given the building's age, it was found to be in fair condition. Investigation of the interior found minor cracking at wall intersections and floor penetrations which is common for a building of this age.

Image 3: Interior Sink View
Minor cracking on floor

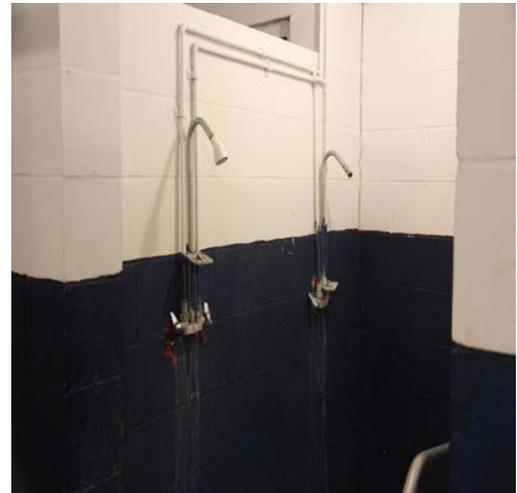
Image 4: Interior Shower View
Minor cracking in corner

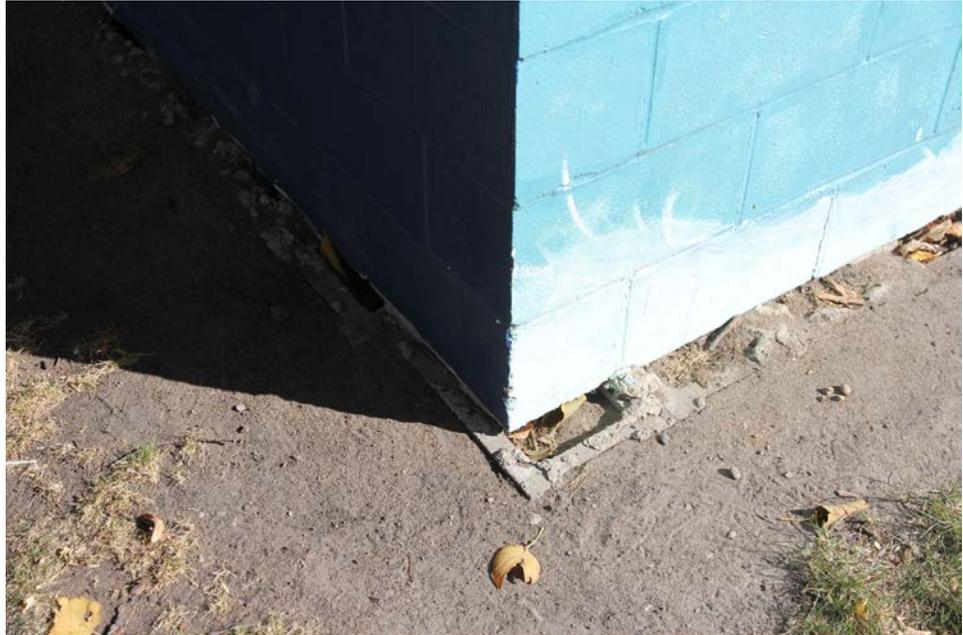
Investigation of the exterior discovered the walls are not placed squarely on the foundation, or possibly the foundation block are wider than the exterior wall block of the bathhouse leaving the cores of the foundation block open to the elements and susceptible to premature structural failure. Currently there is no noticeable foundation damage and or structural failure occurring.

Image 5: *Transition from foundation at exterior corner*

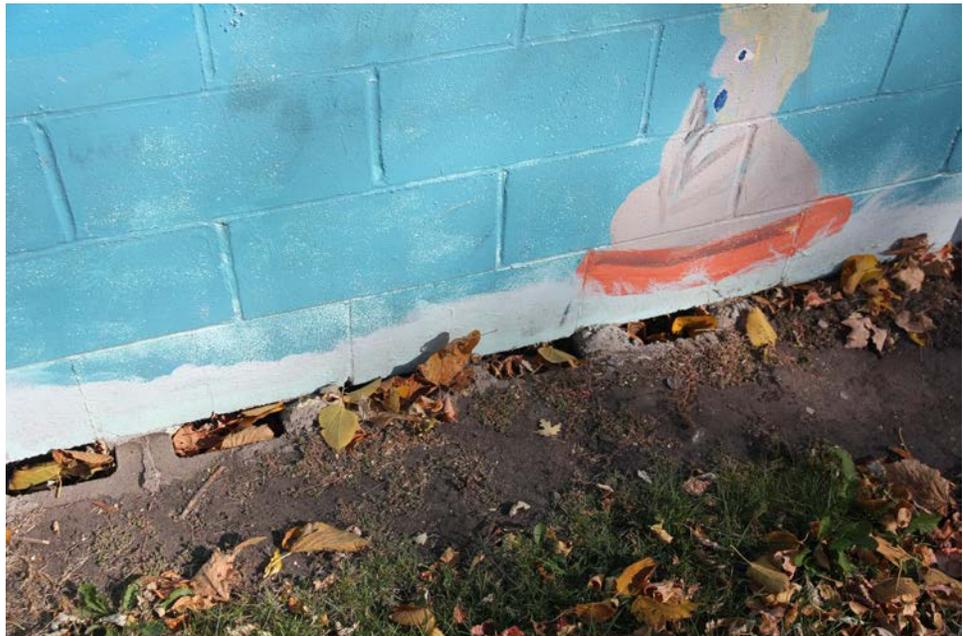
Image 6: *transition from foundation to exterior wall*

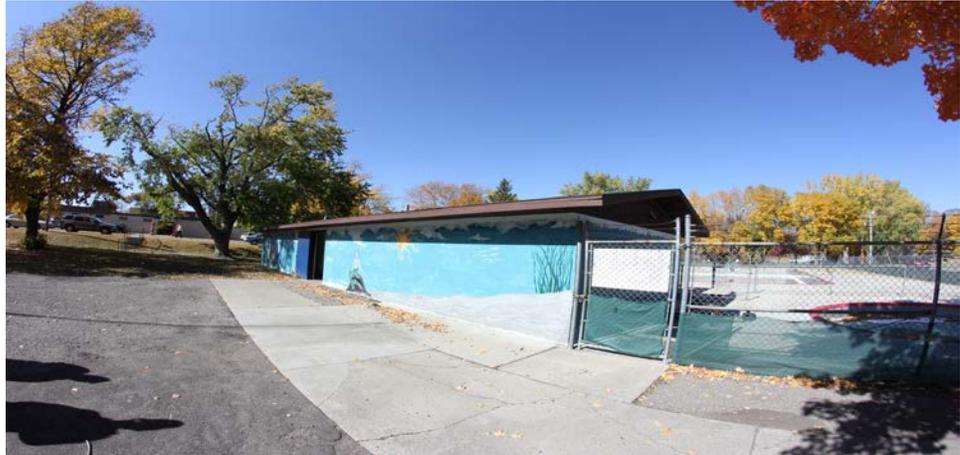
The existing route from the accessible parking stalls to the front of the bathhouse is a firm, stable and slip resistant concrete surface with minor to moderate cracking and slab uplift at control joints that will need to be addressed by either removal of damaged concrete or grinding to level off uneven control joints.

Image 8: *accessible route from accessible parking to front entrance*

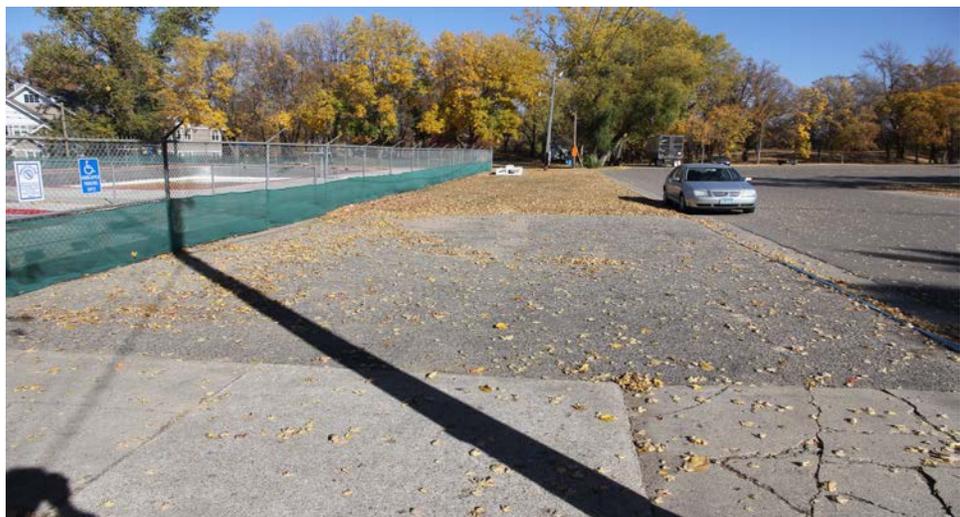
Appropriate signage with the international symbol of accessibility is required to be posted either on a sign post / building / or fence directly in front of the parking stall, centered on said stall at a height of 6 feet from pavement to bottom of sign. One sign should be labeled with “van accessible” below the international symbol of accessibility.

Image 9: *view of accessible parking stalls with signage*

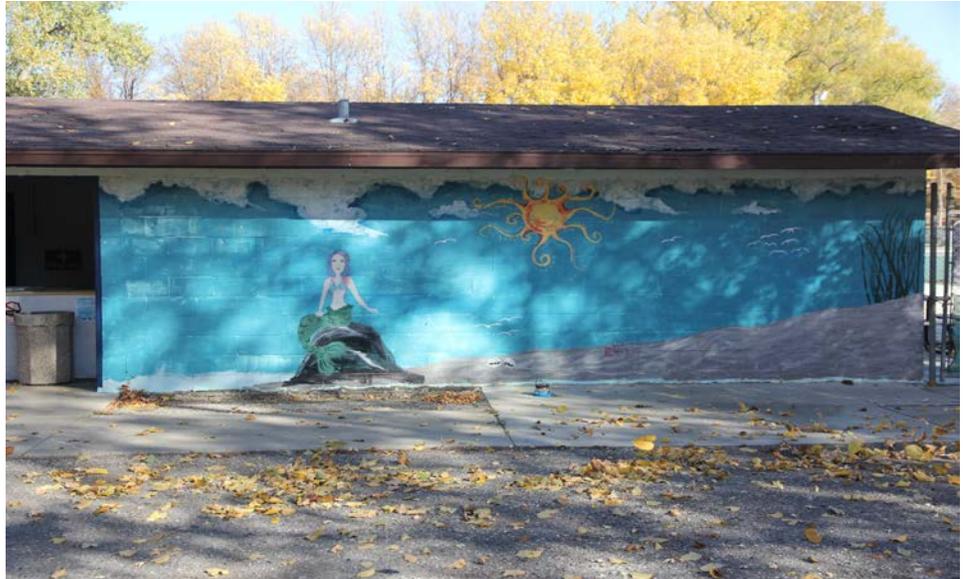
There are three (3) entrances to the building. The South Entrance is the “main” entrance and is for the admission of pool patrons. This door is four feet wide and held open during operating hours. The threshold is ½” high or less. The other two entrances are for entering or exiting the changing rooms from the pool. They are 3 feet wide and are not held open during operating hours. The thresholds are ½” high or less.

Image 10: view of front entrance

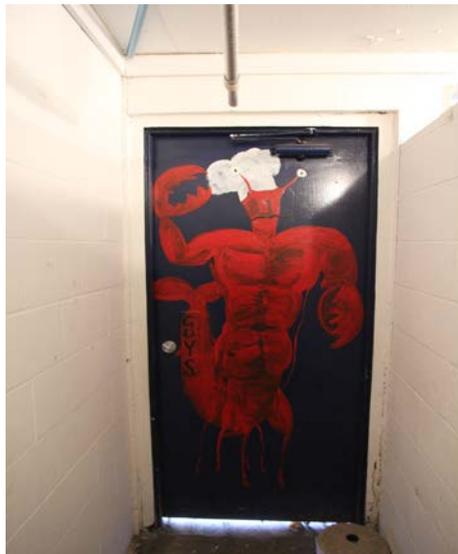
Image 11: Boys Changing Exit

All doorways meet the minimum clearance requirement of 32 inches wide when fully opened. However, the doors entering and exiting the changing rooms from the pool side of the building do not meet the required 12/18 inch push/pull clearance requirements. The Front entrance (south side) meets the push/pull requirements, but does not have sufficient clear floor area on the interior side of the door. Doors entering/exiting the chemical room and the filter room are not required to be accessible. The door exiting/entering the office area from the pool does meet accessible guidelines.

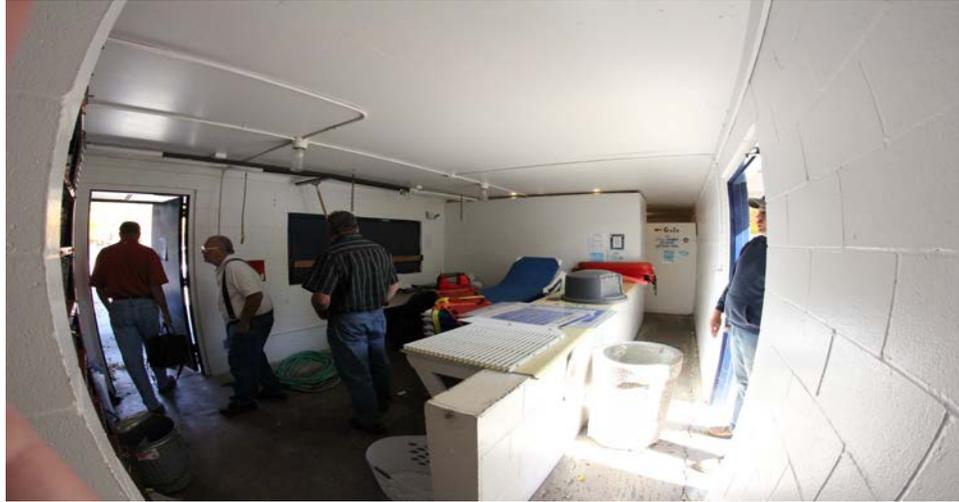
The minimum requirement for an accessible route is 36" wide. Currently there are no accessible routes within the Pelican Rapids Pool Bathhouse. All corridors are 32-3/4" wide or less. In the two locations where the corridor width is greater than 36", the required width is 60" for proper door swing clearance. Current clearances of these corridors are 41 inches.

Image 13: View of admissions and corridor to women's changing room

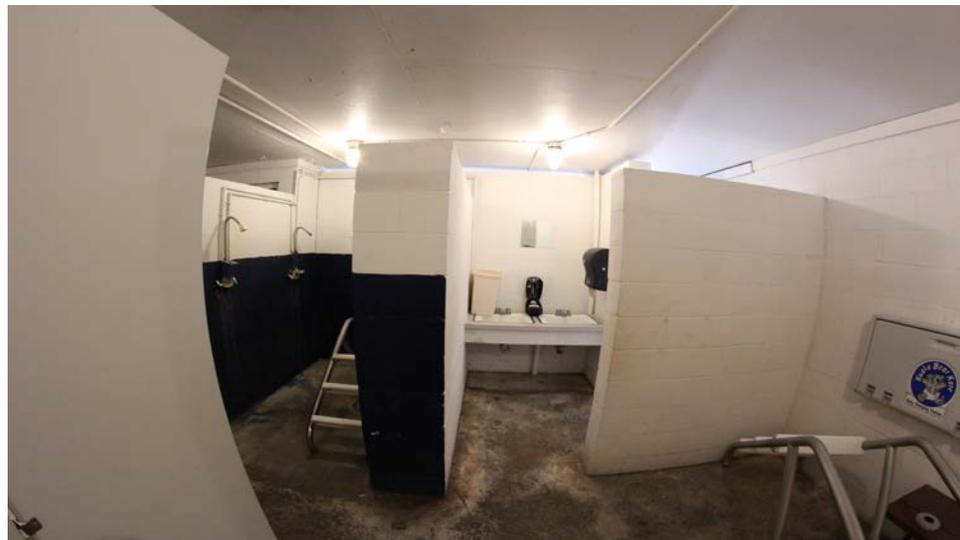
Image 14: View of men's changing room

Incandescent Lighting

The Incandescent lighting with the vapor proof fixtures should be replaced with more efficient fluorescent or LED style lighting. A cost conscience option is to replace the incandescent lamp with a screw-in compact fluorescent lamp.

Toilets: Do not meet accessible clearances to accommodate a wheelchair. Toilets should be replaced with low consumption commercial type, flush valve toilets

Showers: Do not meet accessible clearances to accommodate a wheelchair. The shower controls present a burn hazard.

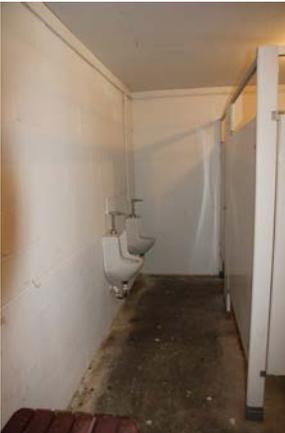
Urinals: Mounting height of urinal is not within the specified parameters to be accessible. Clear floor space in front of urinal is insufficient. Urinals could be reused if mounted to ADA specifications.

Routes: There are currently no accessible routes to or from the men's or women's changing areas.

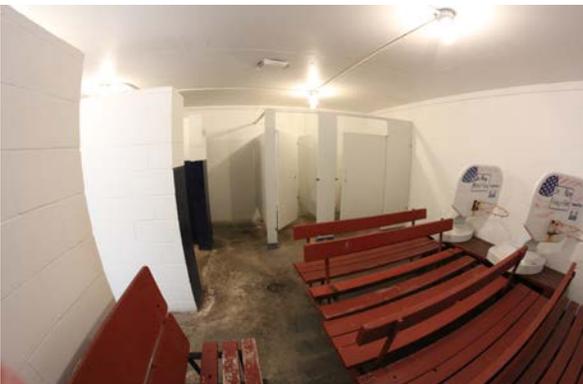
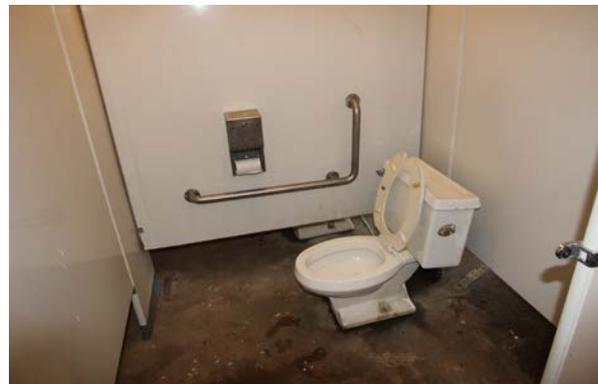
Image 18-21: Interior views of the changing rooms

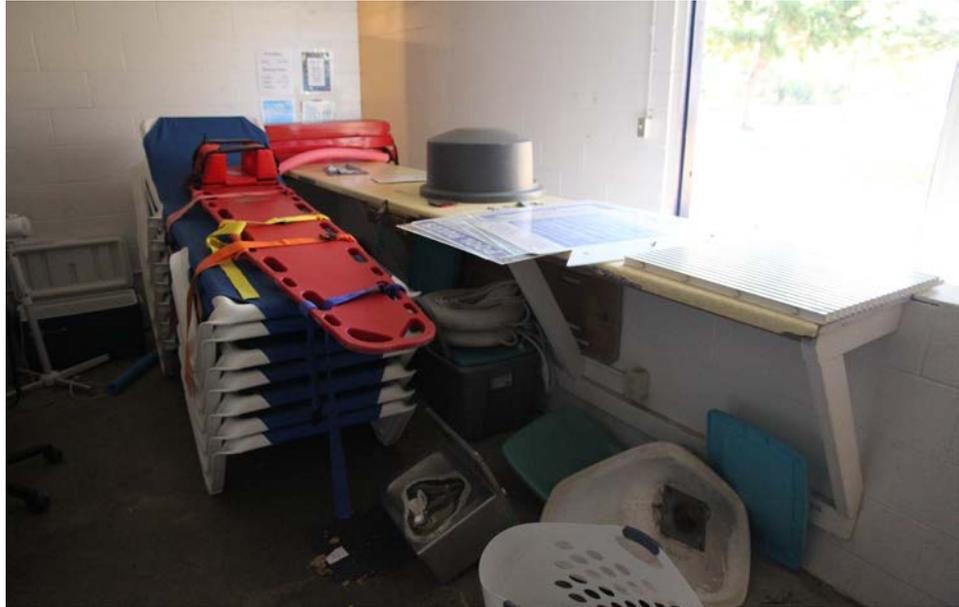
Admissions Counter: Height of counter top is approx. 3'-2". A portion of the counter is required to be at 36" high for a minimum of 3 feet long. Clear floor area in front of counter is insufficient to meet accessibility requirements.

Image 22: Interior view of admissions counter

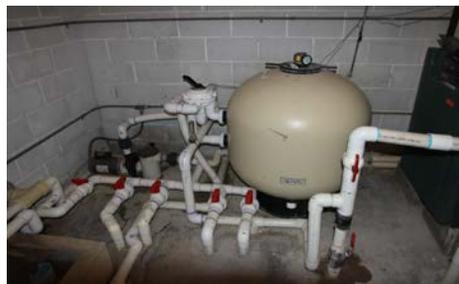
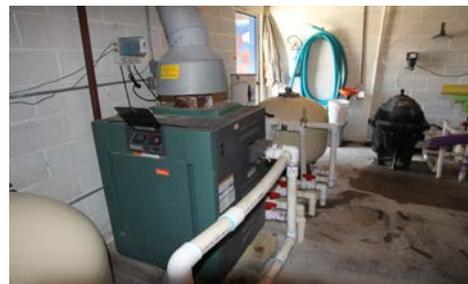
Plumbing: *Plumbing systems in this area appear to be adequate for the existing pool system and facility's needs, however, these systems appear to be in below average condition.*

Water Heaters: *Water heaters are residential tank type heaters and should be replaced with commercial style water tanks.*

Electrical Panel: *Poor condition and should be replaced.*

Image 24 & 25: Interior views of the filter room

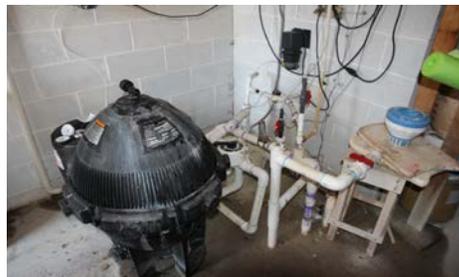
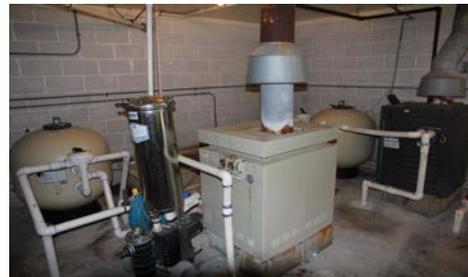
Image 26 & 27: Interior views of the filter room

Natural Gas: *Natural gas service and piping appear to be in operable condition and meet current needs.*

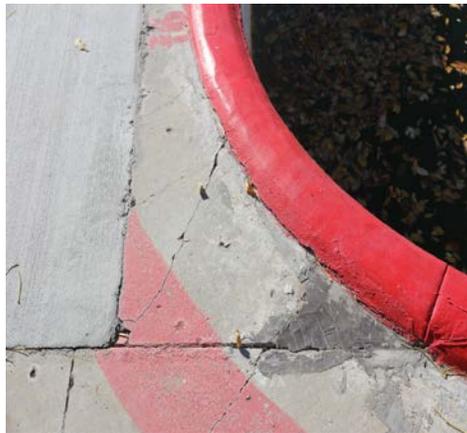
The Concrete Deck that surrounds the pool is a firm, stable and slip resistant concrete surface with minor to moderate cracking with some slab uplift at control joints that will need to be addressed by either removal of damaged concrete or grinding to level off uneven control joints. At this time there are many areas around the pool deck that could possibly contribute to physical injury of users by uneven slabs becoming tripping hazards and toe stubbers. Pool deck will need to be removed if the city decides to repair the underground piping and pool perimeter coping.

Image 31: Perimeter coping of Pool

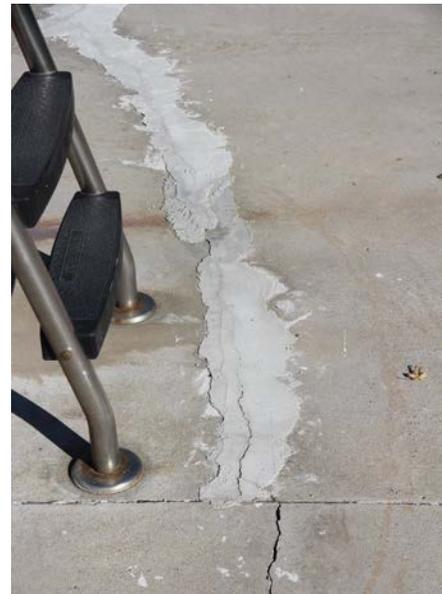
Image 32: Concrete Pool deck

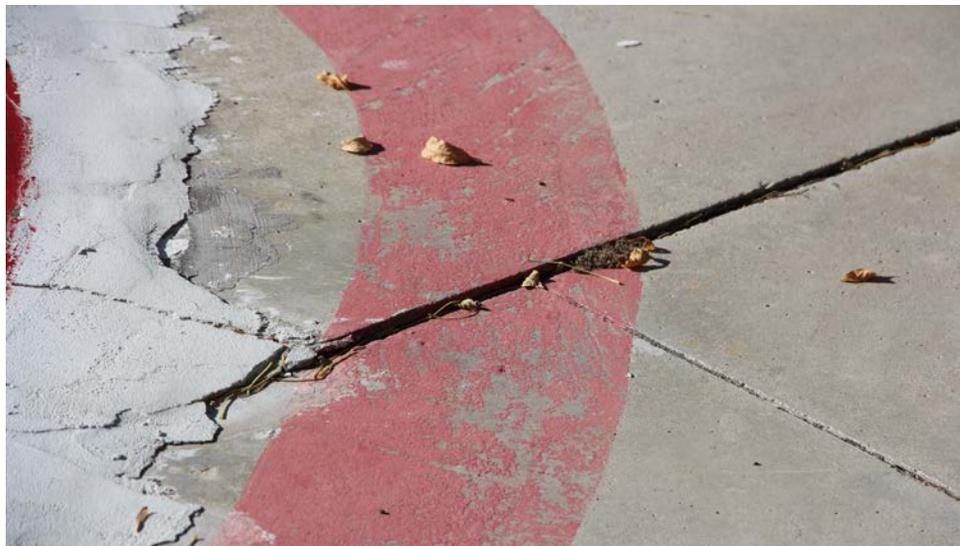
Image 33: Concrete Pool deck

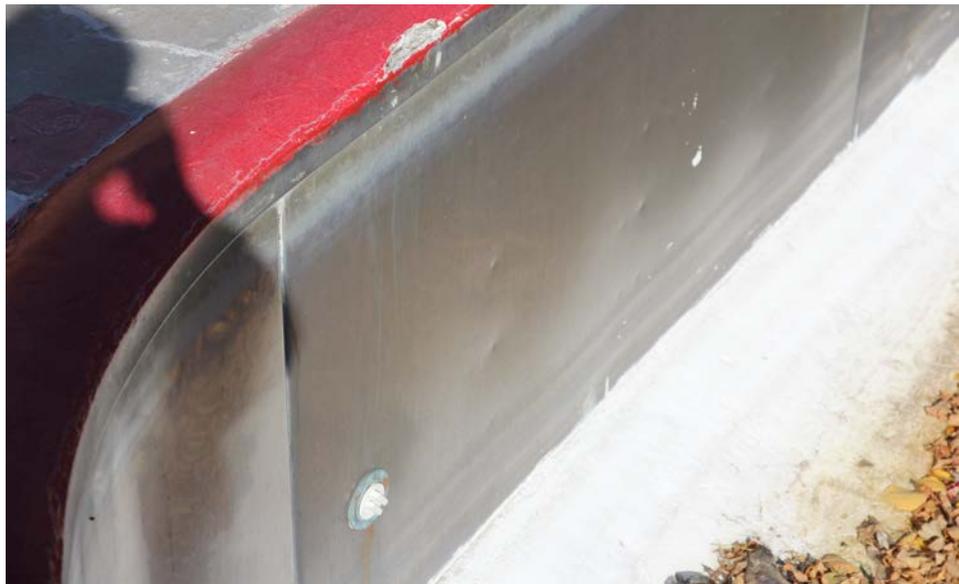
- a. Age of the stainless steel wall panel system and integrity of its structural tieback system.

1. Cover existing stainless steel wall panels with 3-4 inches of shotcrete while using the existing stainless steel wall panels as a backform. (overall pool size will be reduced)
Estimated Cost: \$120,000

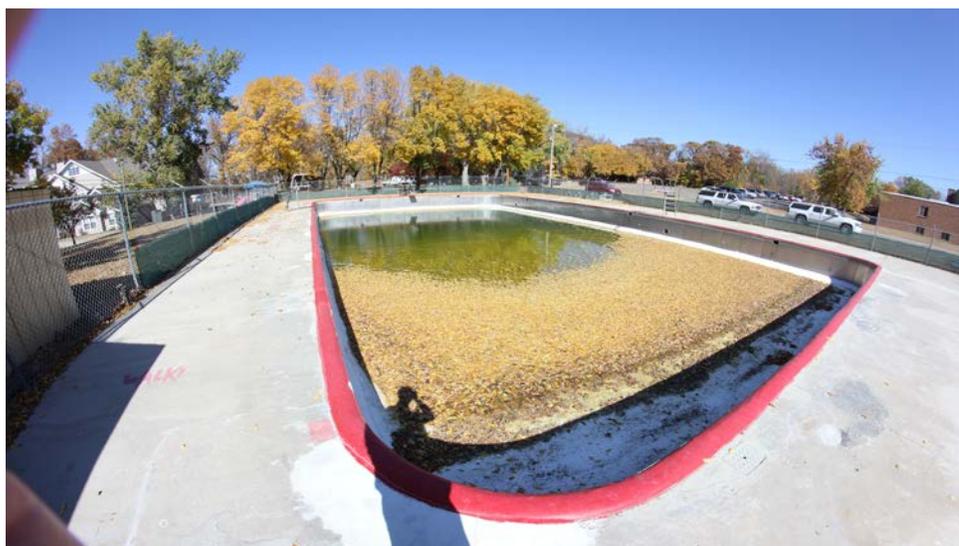
- b. Poor condition of the pool floor structure with extensive cracking.

3. Sandblast existing concrete pool floor, fill cracks and apply an epoxy paint finish to the floors and walls to both main pool and wading pool.
Estimated Cost: \$70,000

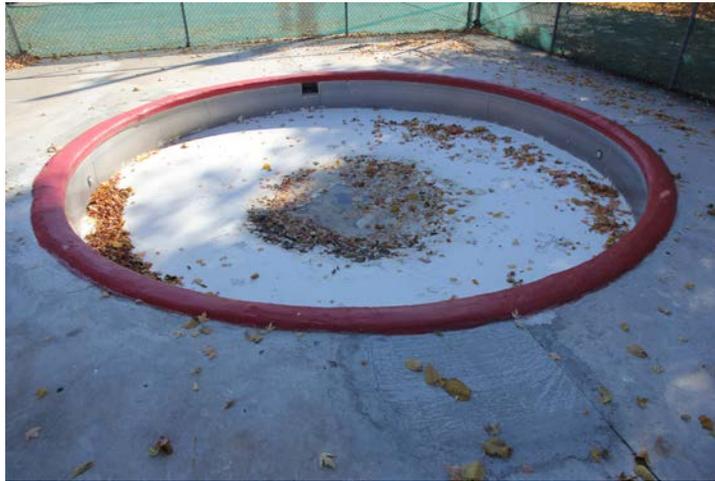
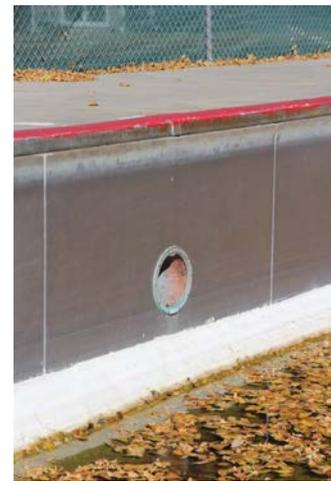
- c. Loss of water due to cracks and potential underground pipe leaks. The city estimates 1,000 gallons of water is lost per day.

4. Replace existing main drains with Anti Entrapment VGB compliant sumps, grating and underground piping to filter room. (main and wading)
Estimated Cost: \$35,000

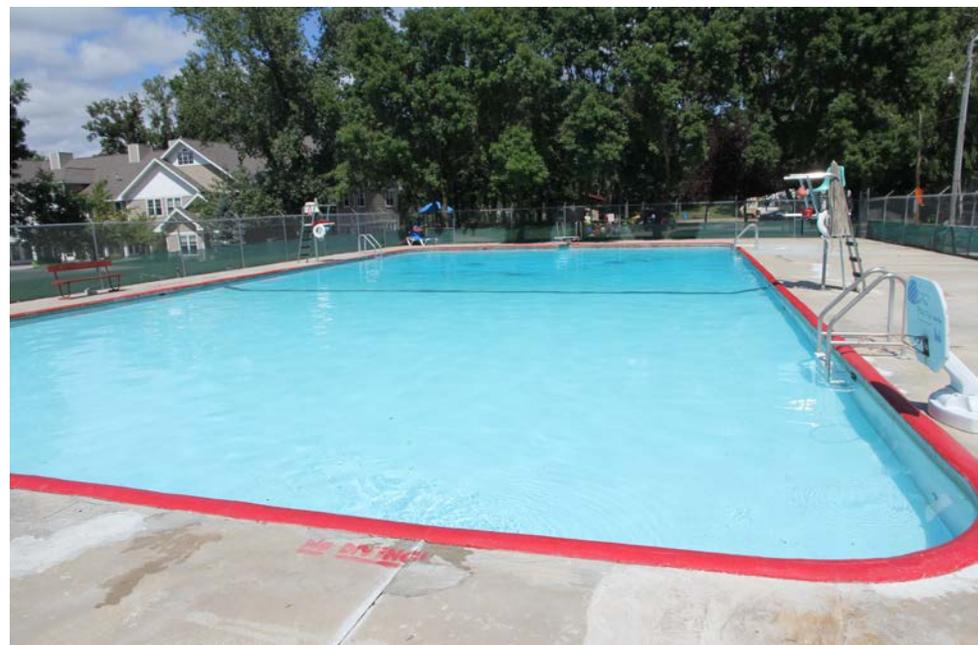
- d. Pool is not in compliance with industry safety standards, Americans with Disabilities Act (ADA), Pool and Spa Safety Act – Anti Entrapment (VGB), Minnesota State Health Code and 10 State Aquatic Design Standards.

6. Install battery operated ADA access lift and one set of walk-in-steps in corner of shallow end of pool. Install ramp with rail into wading pool.
Estimated Cost: \$24,000

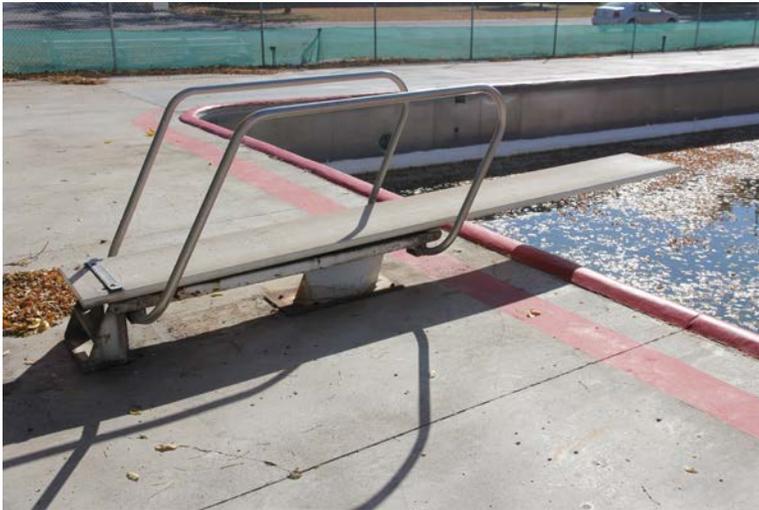
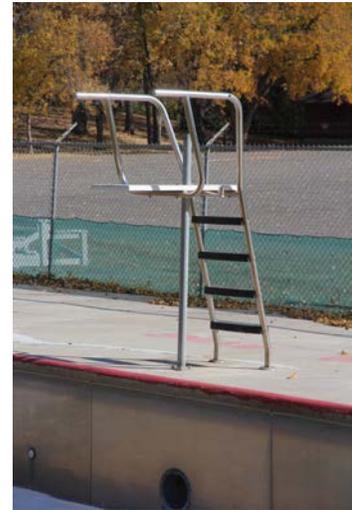
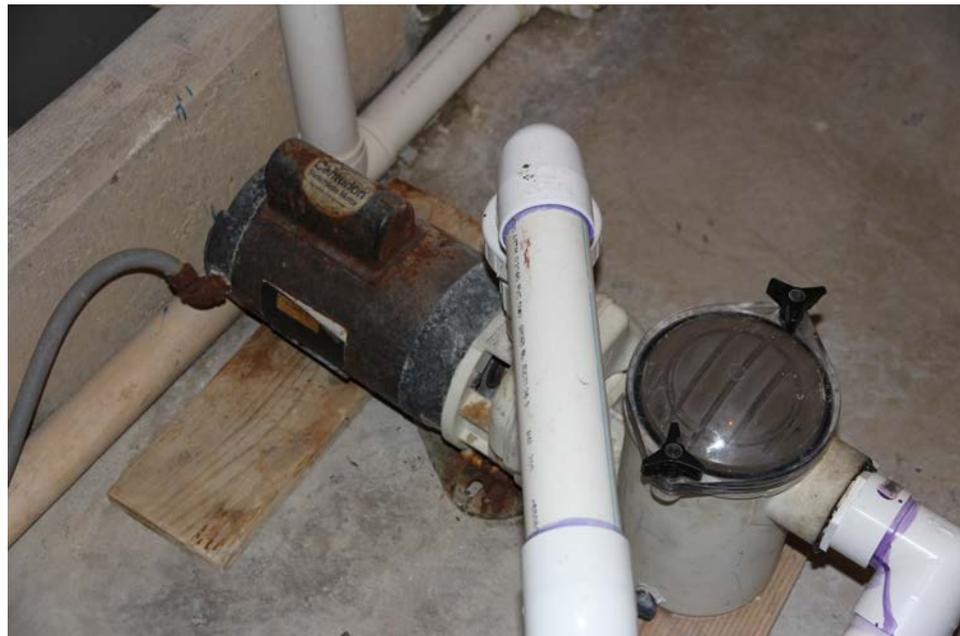
The pool was built in 1978 and is approximately 34 years old. The standard life expectancy of a stainless steel wall panel pool, which is how the Pelican Rapids pool is constructed, is 35 to 45 years. The City of Pelican Rapids has been experiencing difficulties with the pool as of late. The city asked the Design Intent Architects team to inspect the pool and develop recommendations to rectify the reoccurring difficulties. Our inspections uncovered a multitude of concerns, these concerns being:

- e. The existing pool is outdated and does not meet today's construction standards or leisure water amenities / components that communities are expecting from swimming pools.

- f. Increased costs associated with current operation and maintenance under existing conditions.

2. Replace existing skimmers with new skimmer inlet recirculation system along with piping / wall inlets to filter room. Install new mortex formed coping edge / waterline tile to tie in with new concrete perimeter deck construction. (main pool and wading pool)
Estimated Cost: \$125,000

5. Remove existing pool mechanical equipment and replace with new recirculation pump, disinfection system, chemical controller and water level controller with piping and valves for both main pool and wading pool.
Estimated Cost: \$52,500

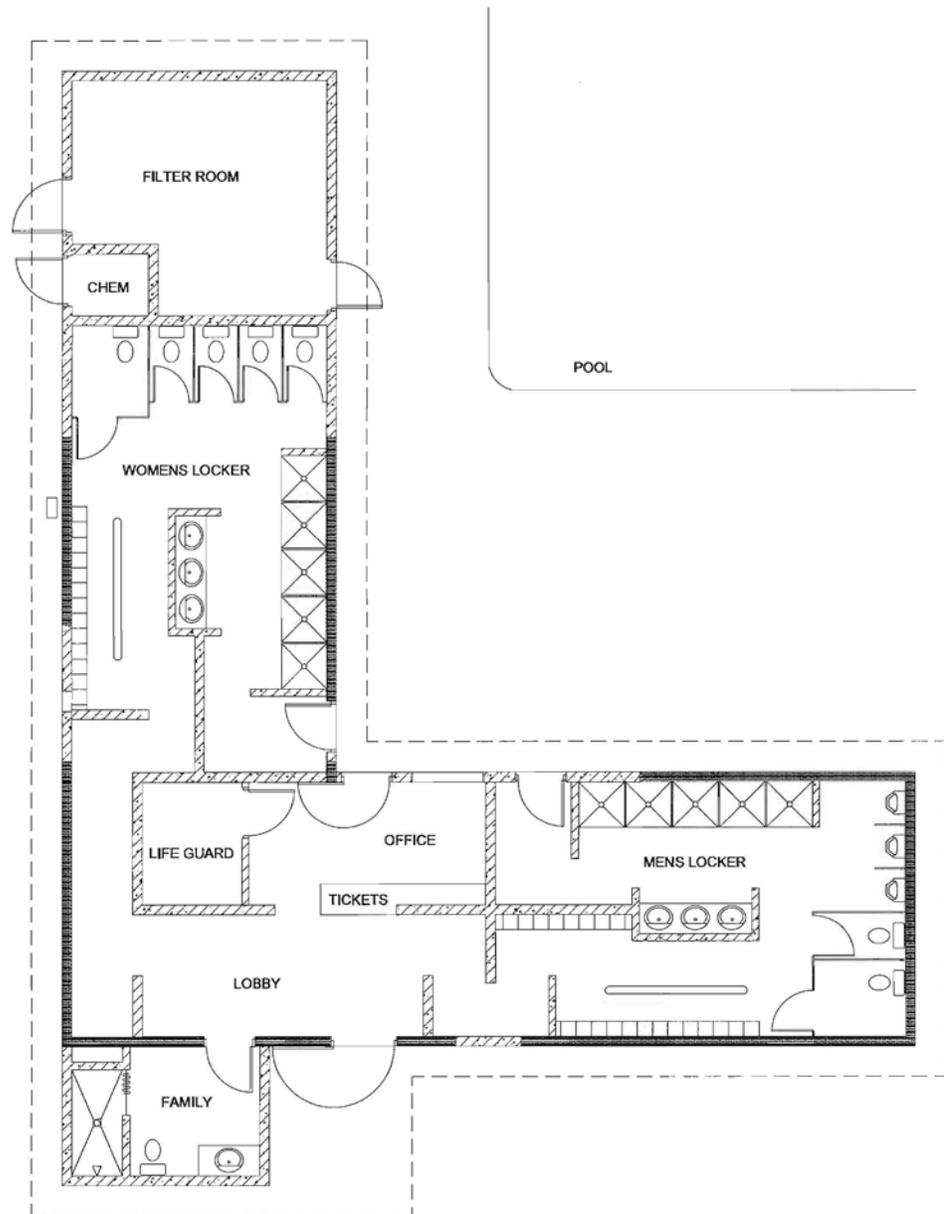
Drawing 2: Proposed bathhouse floor plan – option “A” (1,950 square feet)

The above proposed renovated bathhouse floor plan, accessible parking area with accessible route and accessible pool have been developed based upon community “base” needs and building code / ADA accessibility compliance standards. Costs have been computed based upon upgrades to the existing building, pool, as well as providing accessible circulation routes in building and to accessible parking area. Detailed costs of these renovations have been provided below:

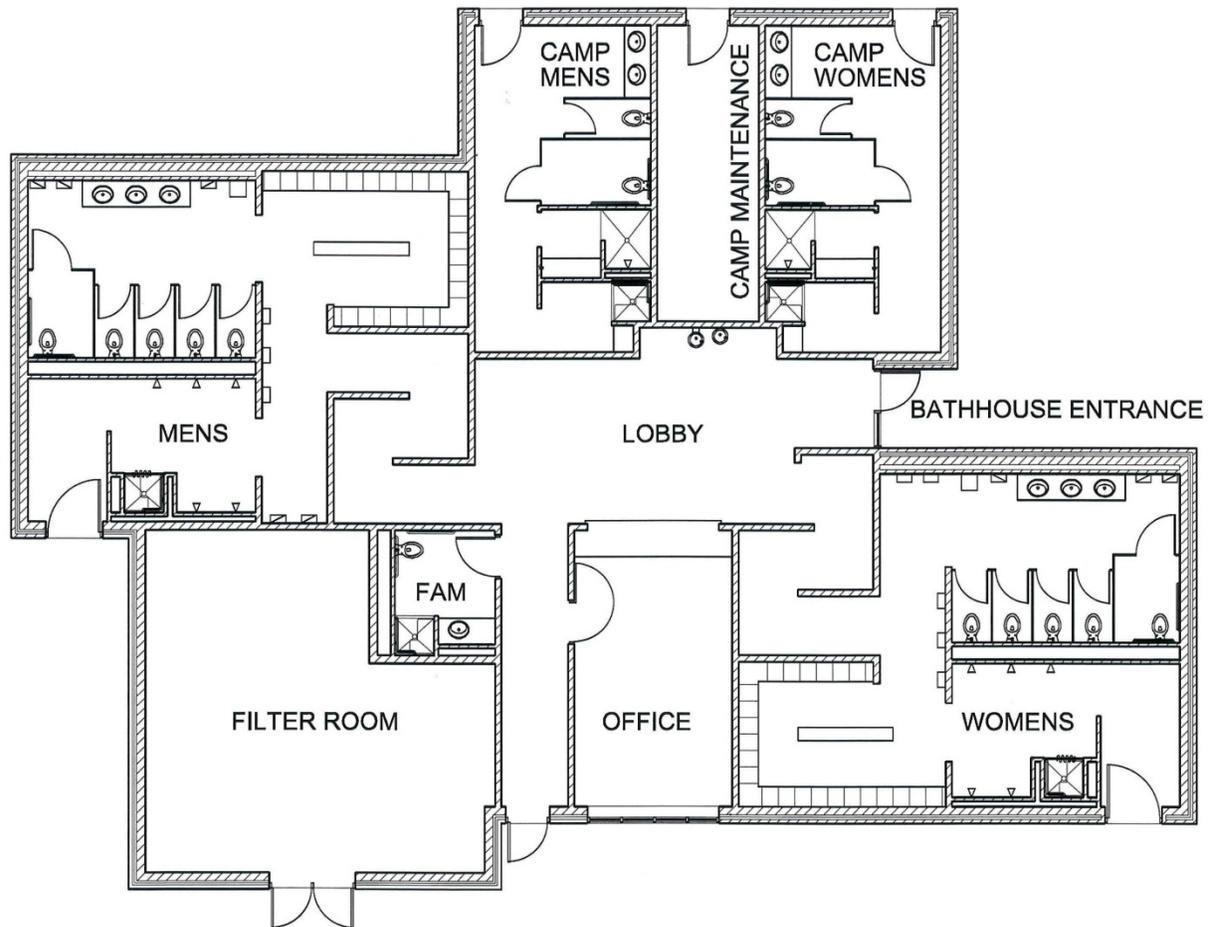
Drawing 4: Proposed bathhouse floor plan – option “B” (4,500 square feet)

The above proposed option “B” bathhouse floor plan includes a 1000 square foot (s.f.) Camp ground convenience toilet / shower addition, 1100s.f. men and 1100s.f. women changing rooms with toilet and shower amenities, 92 quarter size lockers, 340s.f. lobby, 250s.f. staff office with admissions counter, 110s.f. family changing room and a 600s.f. pool filtration room. Exterior amenities include accessible parking area and accessible route with accessible pool, all have been developed based upon community “upgraded” wants and building code / ADA accessibility compliance standards. Costs have been computed based upon upgrades to building, pool, as well as providing accessible circulation routes in and around building and to the accessible parking area. Detailed costs of these renovations have been provided below:

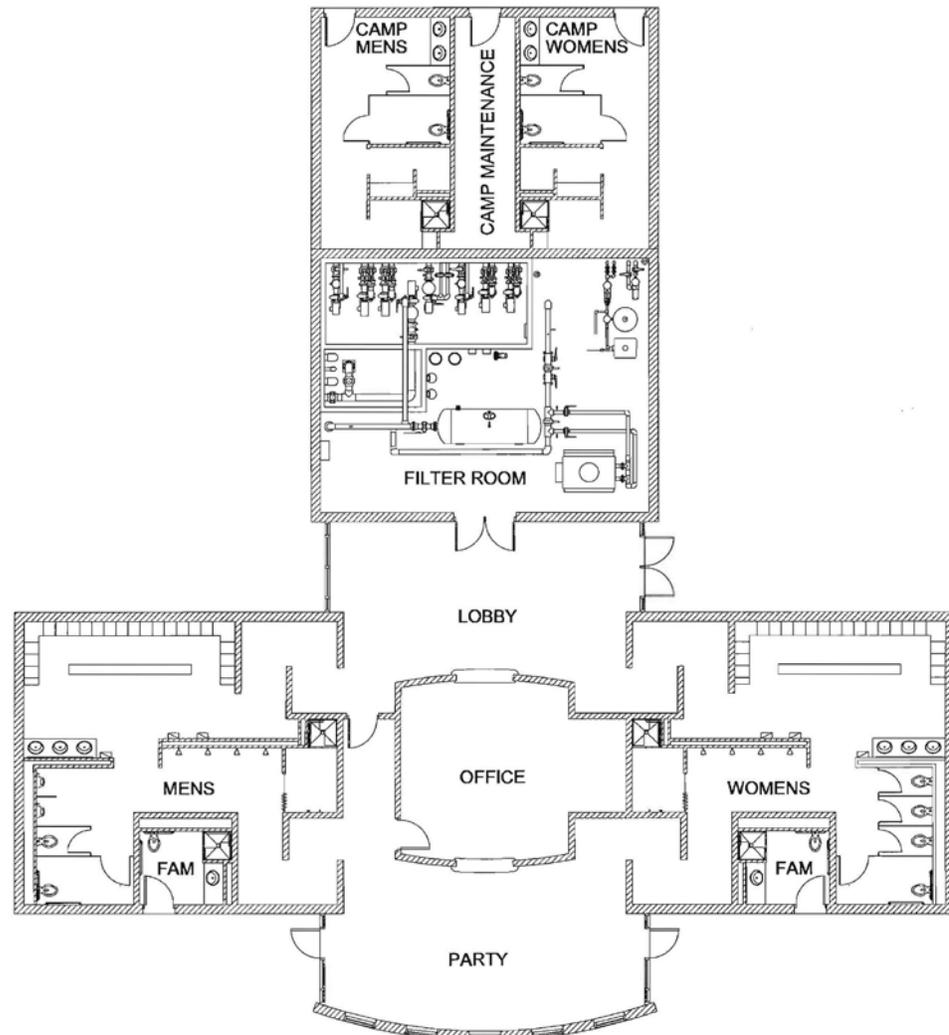
Drawing 6: Proposed bathhouse floor plan – option “C” (5,700 square feet)

The above proposed option “C” bathhouse floor plan includes a 1000 square foot Camp ground convenience toilet / shower addition, 1060s.f. men and 1060s.f. women changing rooms with toilet and shower amenities, 128 quarter size lockers, 505s.f. lobby, 375 s.f. staff office with admissions counter, two 110s.f. family changing rooms, 580s.f. party space and a 900s.f. pool filtration room. Exterior amenities include accessible parking area and accessible route with accessible pool, all have been developed based upon community “upgraded” wants and building code / ADA accessibility compliance standards. Costs have been computed based upon upgrades to building, pool, as well as providing accessible circulation routes in and around building and to the accessible parking area. Detailed costs of these renovations have been provided below:
