Pelican Rapids Dam: Conceptual Design for Dam Modification

Pelican Rapids City Council Meeting
11/27/18

Amanda Hillman –Restoration Coordinator
MNDNR – River Ecology Unit

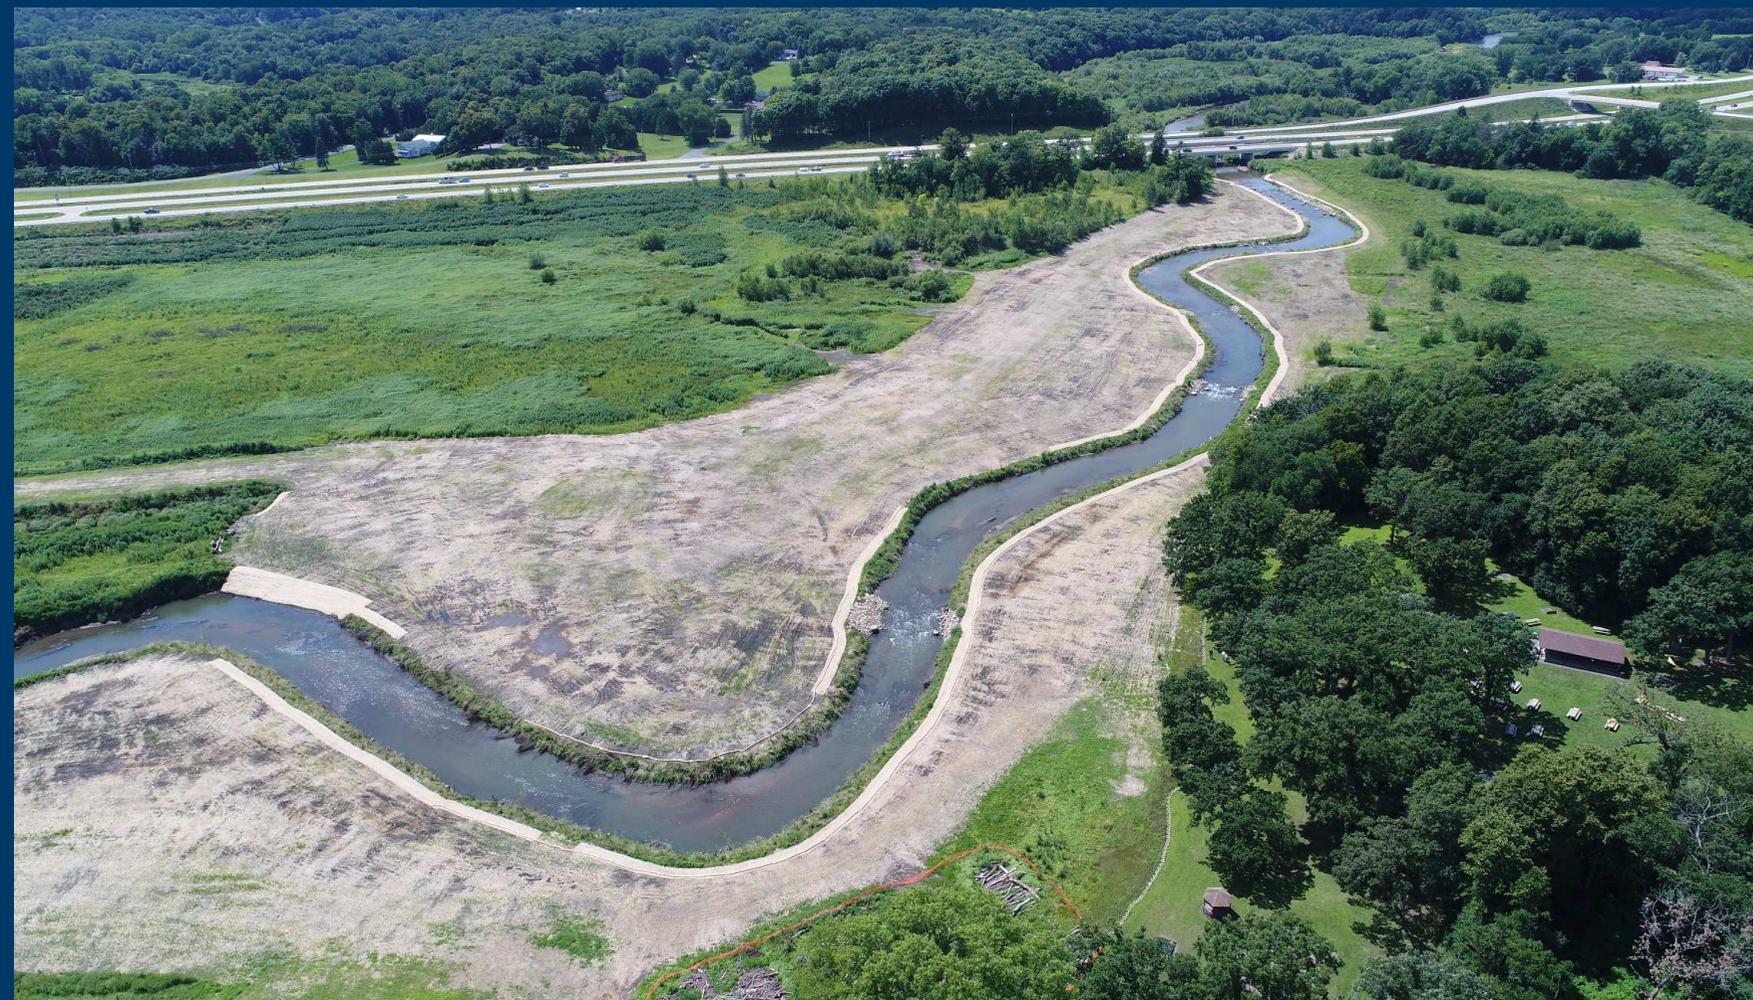
Lake Shady After

- Completed in 2017
- Dam modification and channel restoration in reservoir
- Aerial view of new channel

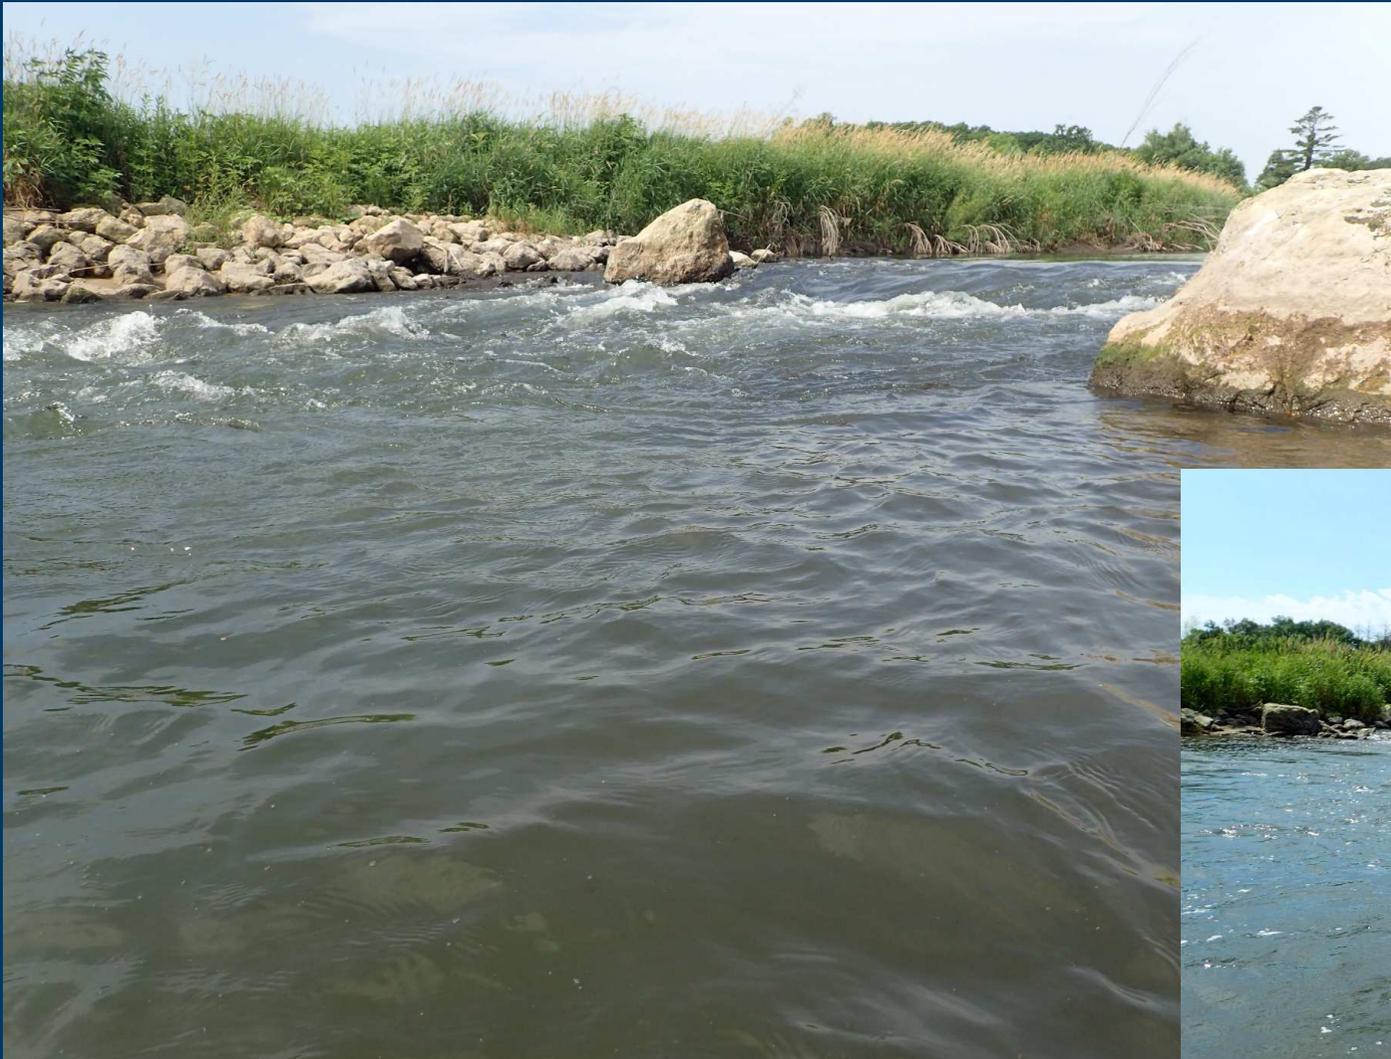
- New river channel and riffles
- About 6 months after construction

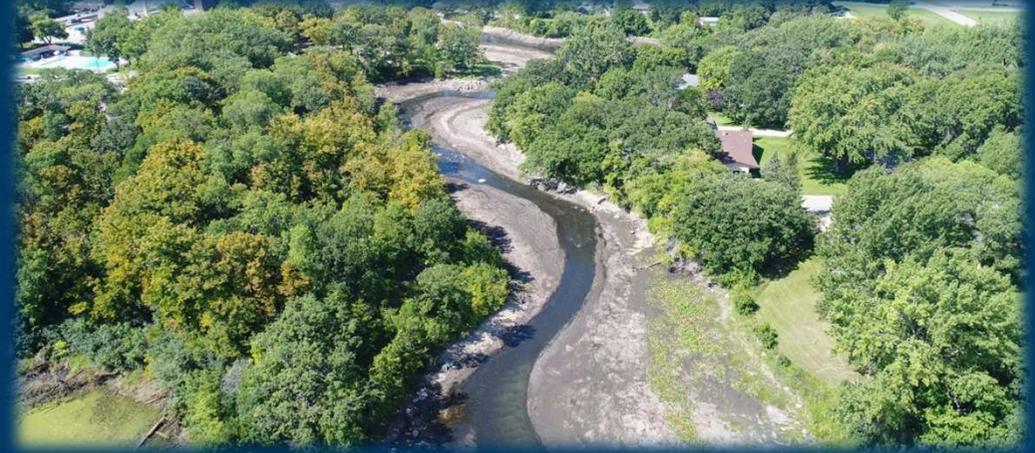
Pelican Rapids - 2017 Draw Down

Drone image by Houston Engineering

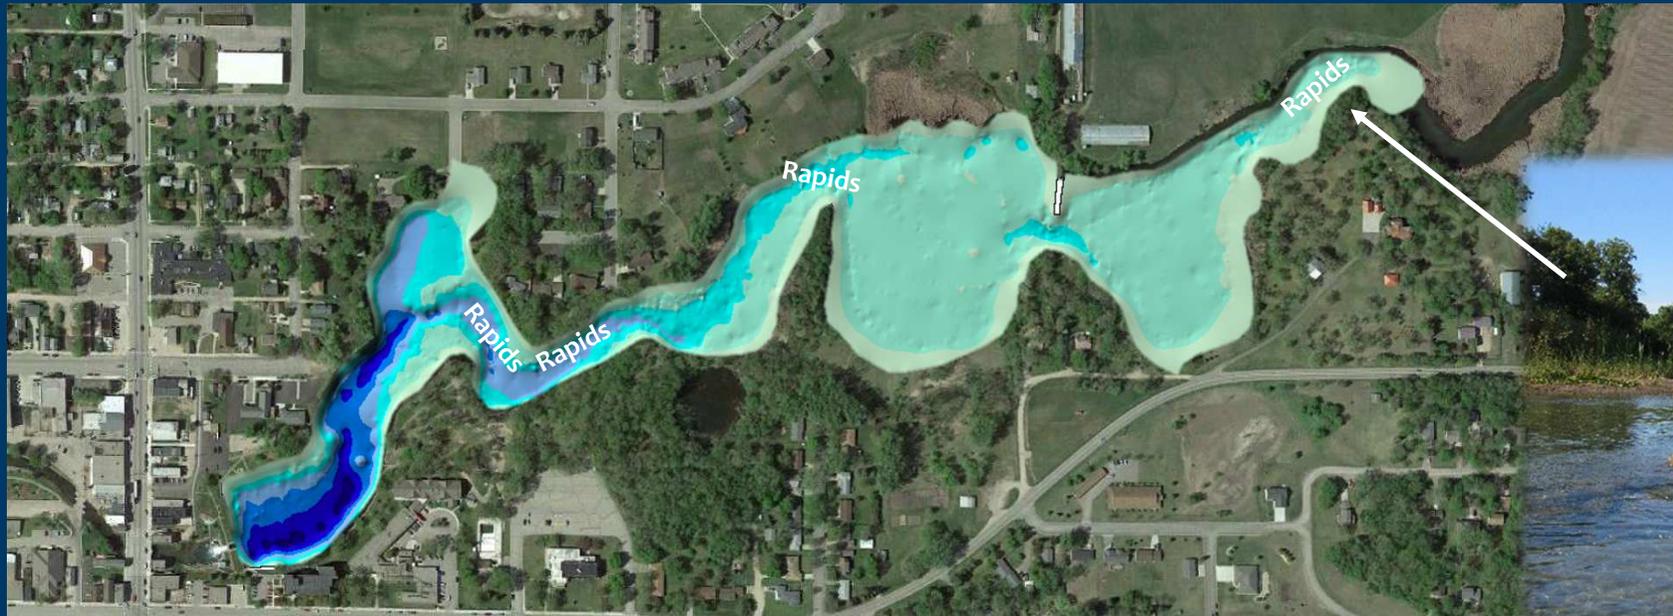
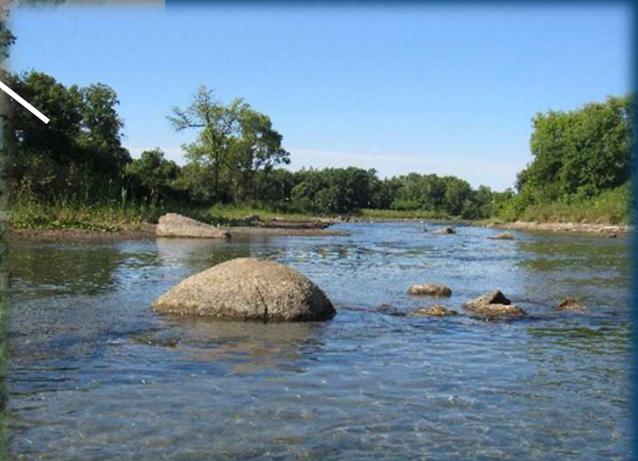
Bathymetry by Jamison Wendel, DNR

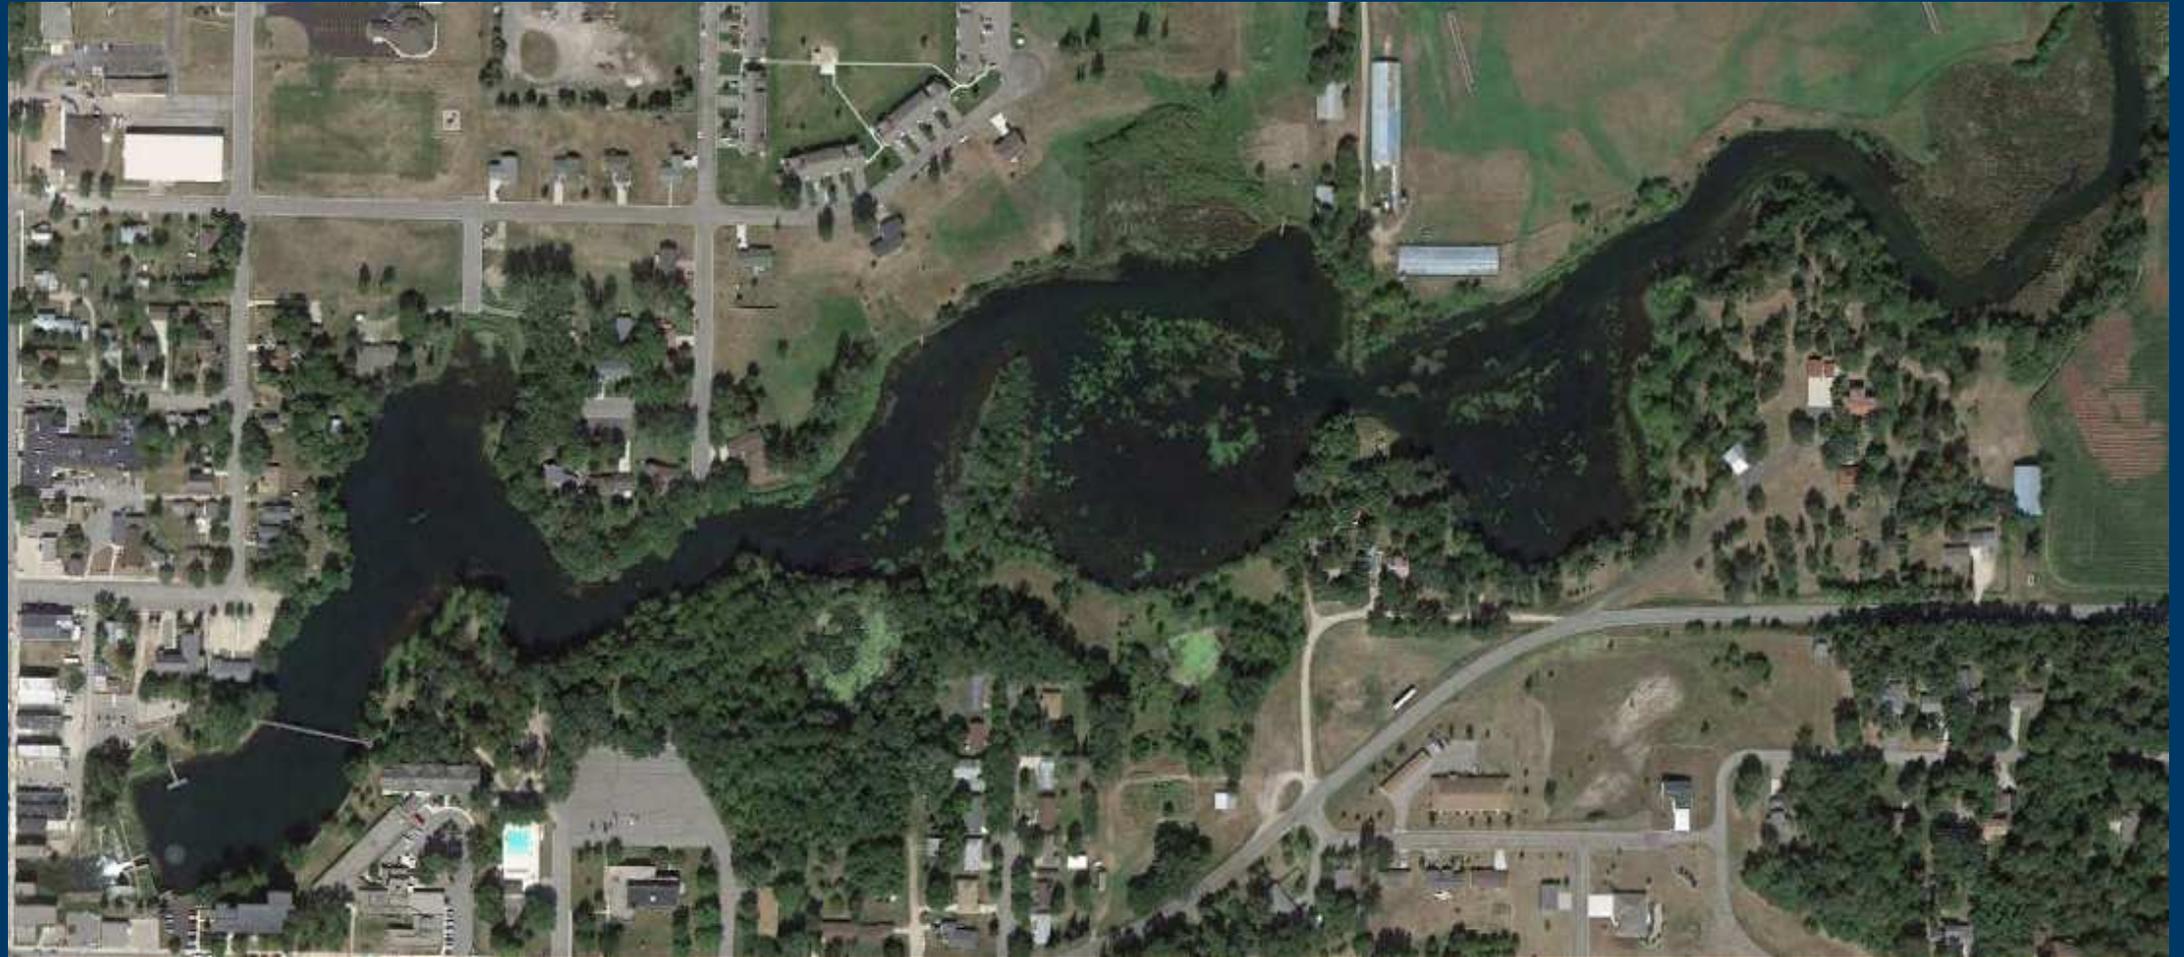
During 2017 draw down
River more narrow than a restored channel would be

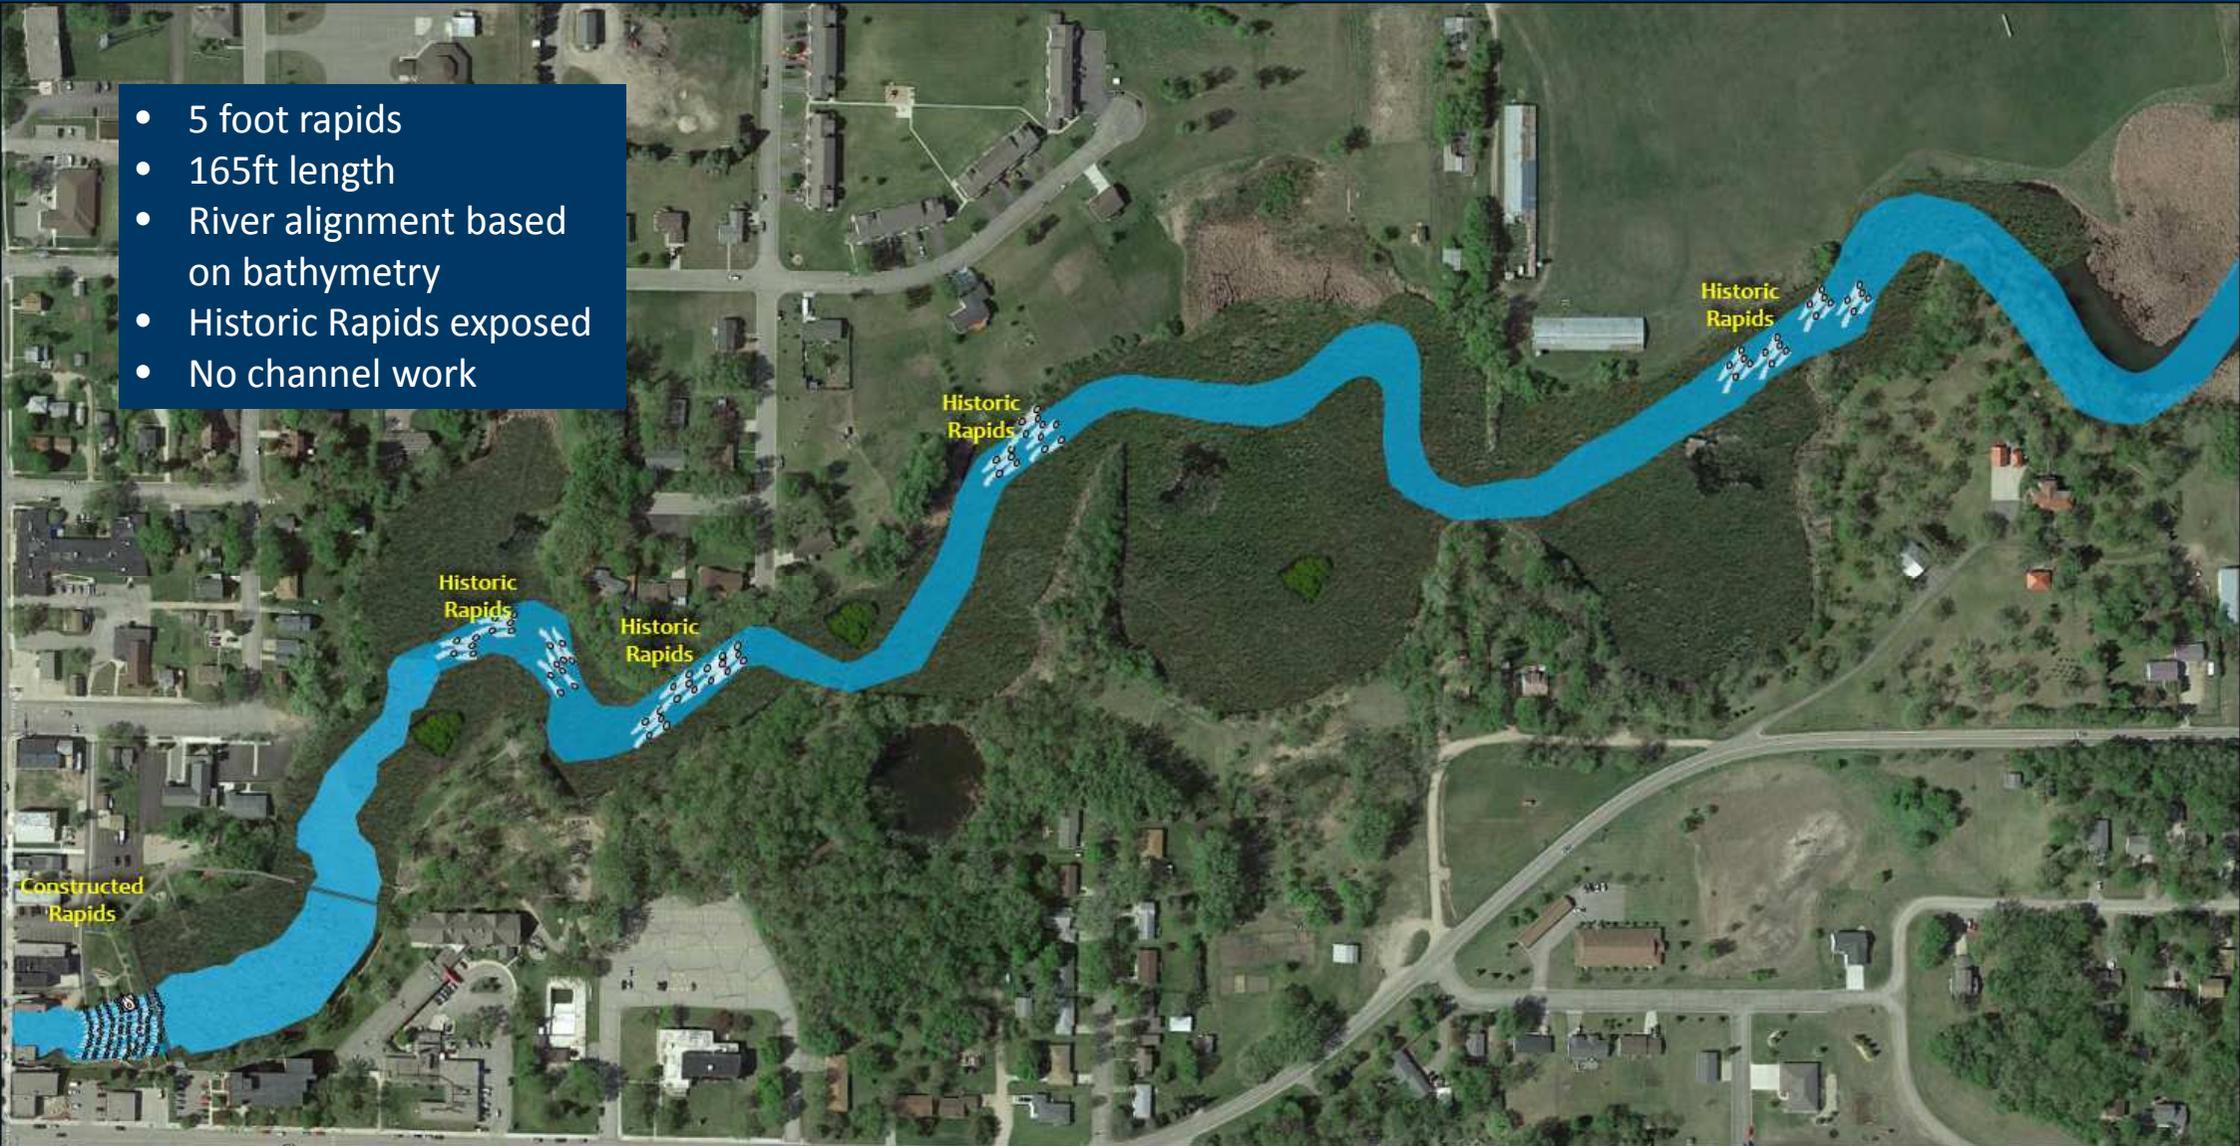
Conceptual Design

- 5 foot rapids
- 165ft length
- River alignment based on bathymetry
- Historic Rapids exposed
- No channel work

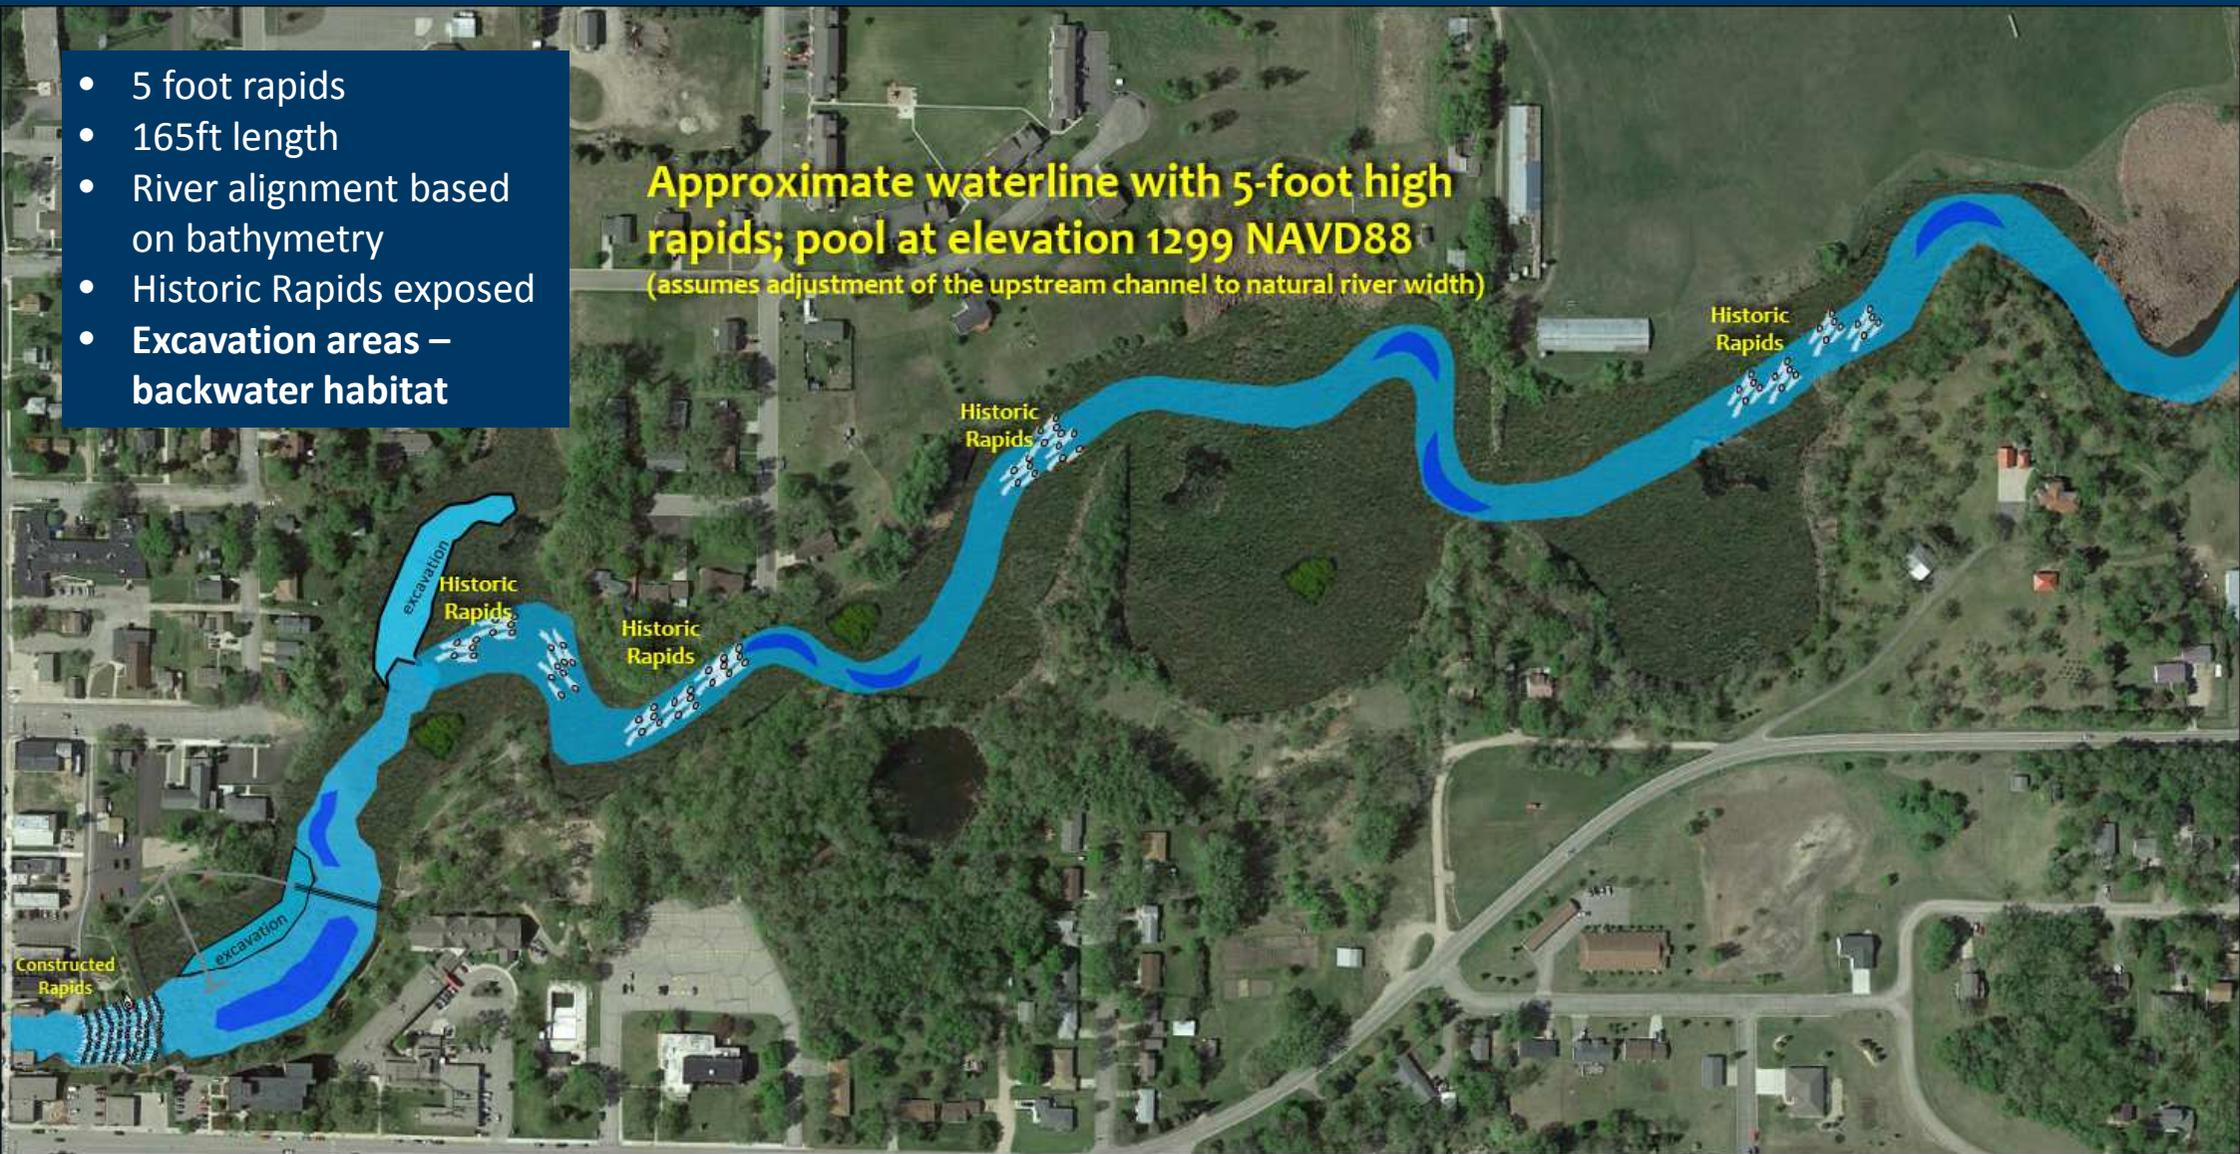
- 5 foot rapids
- 165ft length
- River alignment based on bathymetry
- Historic Rapids exposed
- Excavation areas – backwater habitat

Approximate waterline with 5-foot high rapids; pool at elevation 1299 NAVD88
(assumes adjustment of the upstream channel to natural river width)

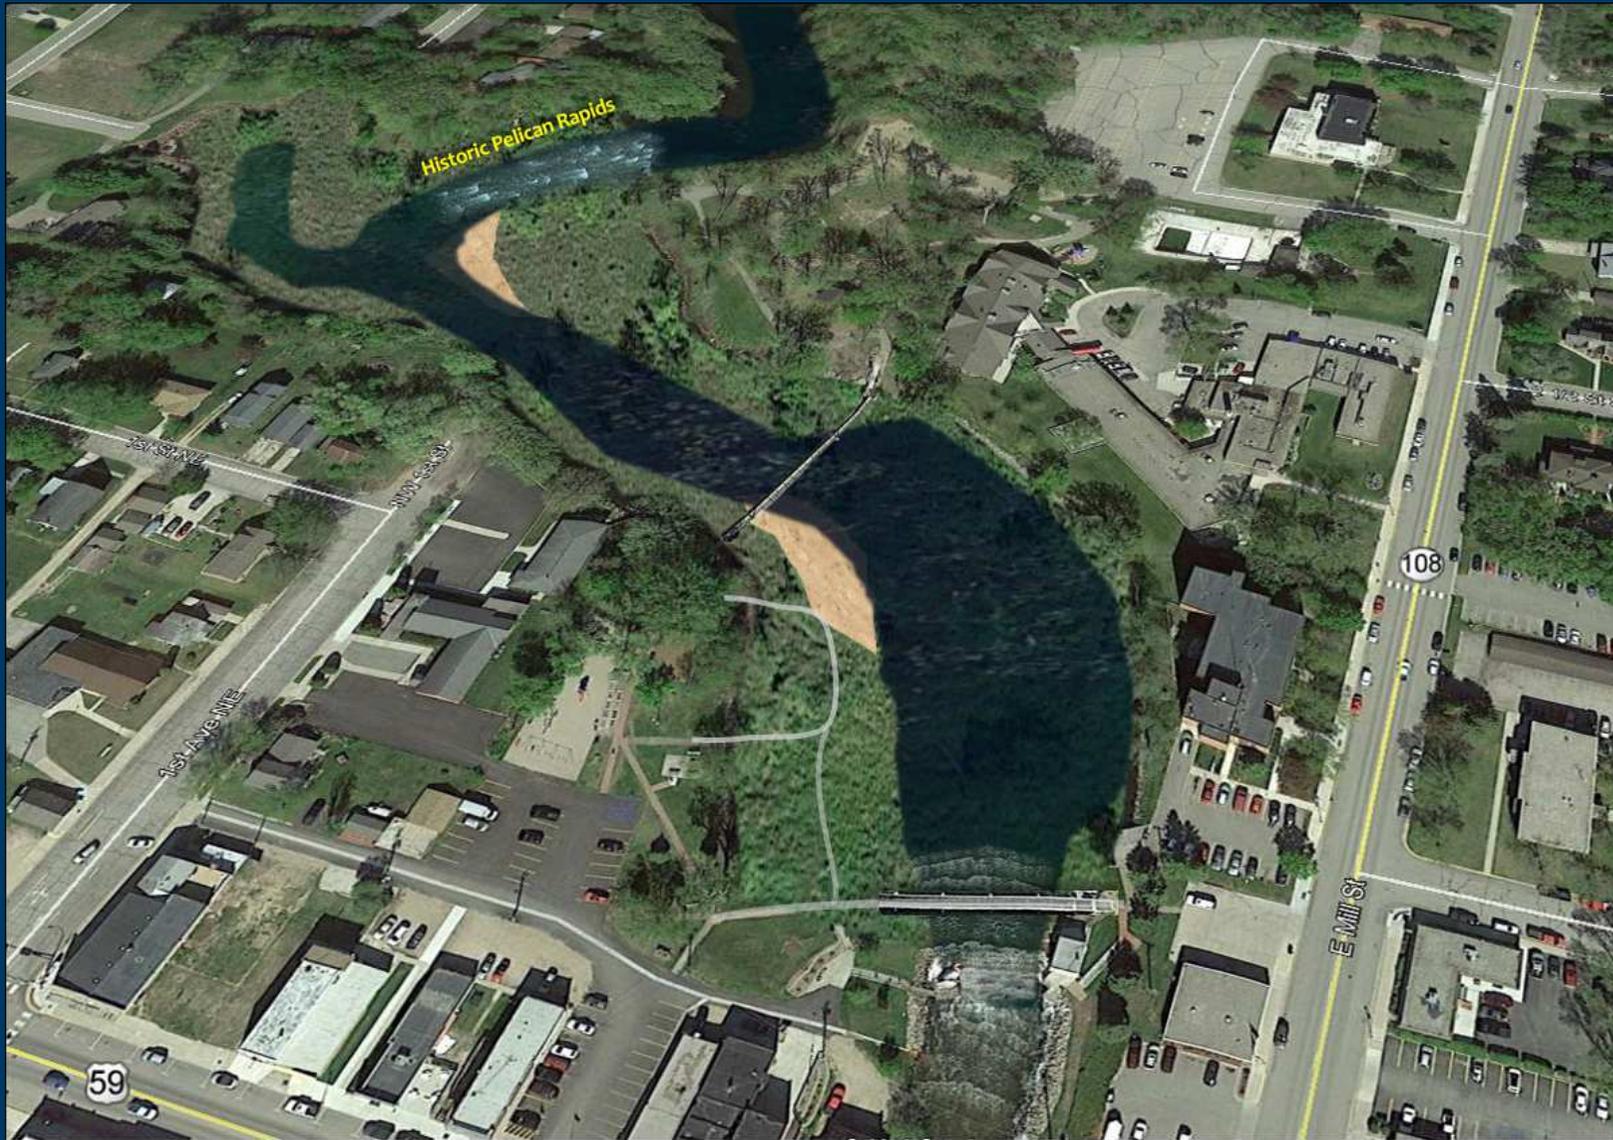
- Bridge would still have ponded water under it
- Upstream view would be of historic rapids upstream
- Trails
- Sandy area
